Project Notification Form

Northern Avenue Bridge Project

City of Boston Public Works Department

July 25, 2019

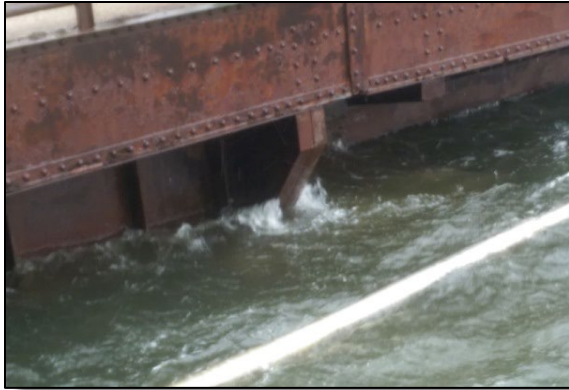
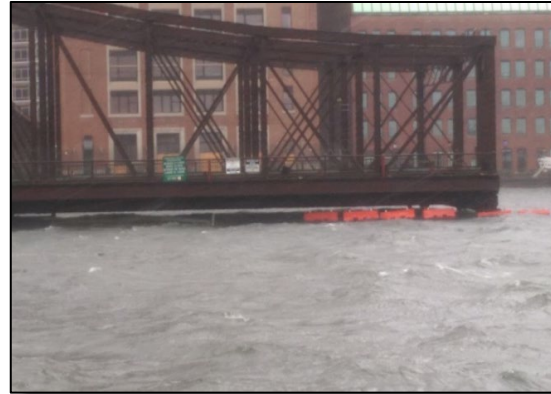
Currently, the bridge underside is submerged in water during storm events. This direct exposure to salt water worsens the severe condition of the floor system and the lower portions of the truss. Below are photos from recent 2018 winter storms when Boston Harbor reached the underside of the bridge.

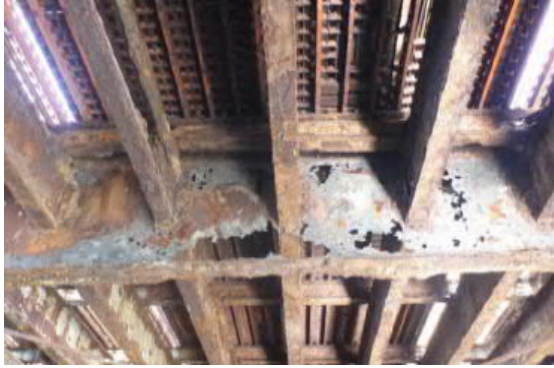
The deck and floor system, including all deck and structural framing elements as well as the sidewalk cantilevers and lower lateral bracing, were inspected in 2013. These members were not re-inspected in 2017 based on the severity of the condition noted during the previous inspection. The deck and floor system were found to be in critical condition due to widespread deterioration, and a portion of the sidewalk cantilevers were noted as a risk for imminent failure at the time of the 2013 report. Refer to Images 1 and 2 below, showing sample floor beam and stringer conditions.

Image 1: 100% Section Loss in a Swing Span Floorbeam

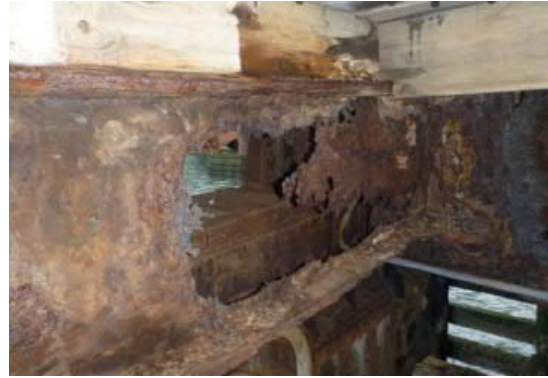
Image 2: 100% Section Loss in an Approach Span Stringer

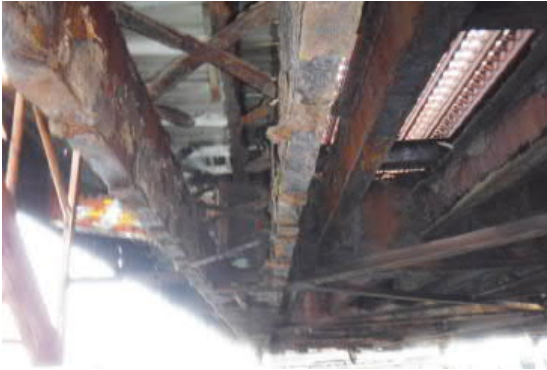
The truss members themselves varied in condition based on their location along the bridge and by element. The lower chord members exhibit moderate-to-severe corrosion and deterioration (up to 100% section loss) concentrated around the ends of the members near the pin assemblies (See Image 3). The upper chord members are observed to be in generally satisfactory condition, with a few scattered deficiencies and corrosion with no significant visible deterioration (See Image 4).

Image 3: Severe Deterioration and 100% Loss of Lattice Bracing in the Swing Span Lower Chord

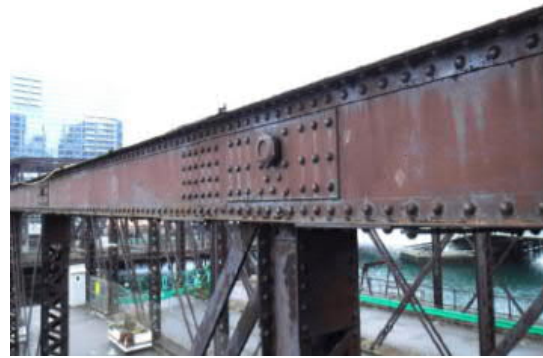
Image 4: Typical Top Chord Member in the Approach Spans

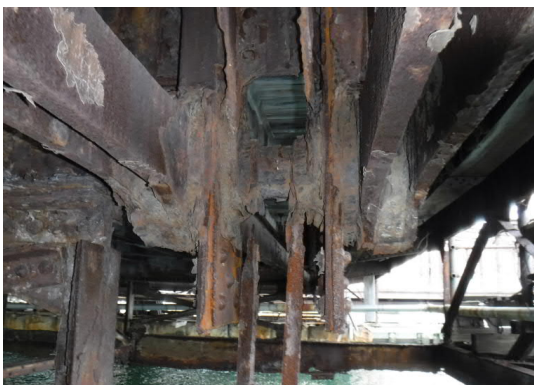
The condition of the vertical truss members vary along their length, with the areas below the deck possessing moderate-to-advanced corrosion and the areas above the deck in generally satisfactory condition with minor deficiencies and scattered corrosion. In general, the portions of the verticals which extend below the deck and pin joint are severely deteriorated, as seen in Image 5.

Image 5: Severe Deterioration of the Verticals Below the Deck and Pin

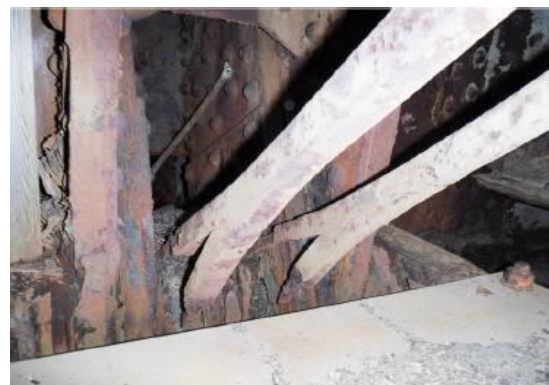
Similar to the verticals, the diagonal truss members generally show moderate-to-advanced corrosion below the deck level, especially concentrated around the pin joint areas. An example of section loss of the diagonals at the lower pin joint can be seen in Image 6.

Image 6: 100% Section Loss of Eye Bars Diagonals in the Swing Span

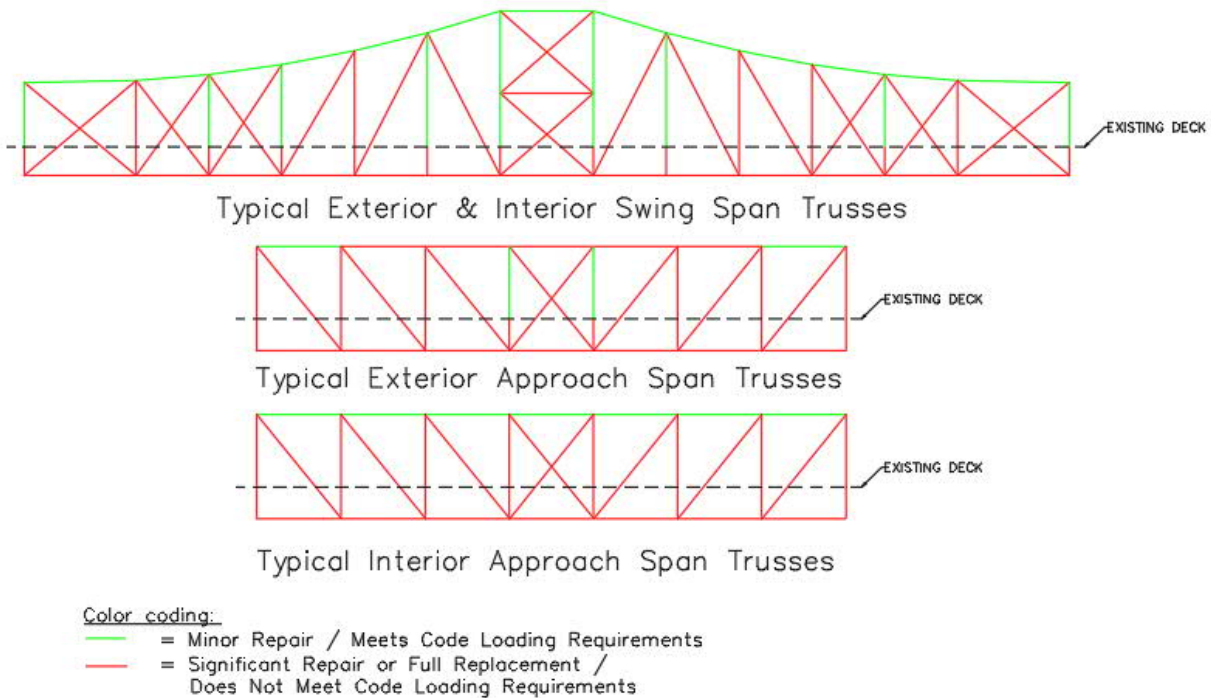
Figure 1: Truss Based on Combined Condition and Capacity

Combining the results of the condition inspection and structural analysis, the elements of the bridge which may be potentially re-used in a rehabilitated structure have been evaluated. As previously discussed, the floor system is beyond repair and would require replacement in any rehabilitation scenario. Figure 1 below graphically shows the summary of the results of the combined capacity and condition analysis for the primary truss elements. The elements depicted in red indicate members which would need significant repair and/or do not meet current load capacity requirements. Members depicted in green would meet current load capacity requirements but may also require minor repairs. The diagram is shown for a typical truss in the structure; there is some minor variation among the spans and trusses. Overall, based on existing conditions and structural analysis, 75% of the exterior and interior swing span trusses, 90% of the exterior approach span trusses and 75% of the interior approach span trusses primary members would require significant repair and/or do not meet load capacity requirements. For the secondary truss elements approximately 25% of the upper sway bracing on the approach spans and less than 20% of the upper sway bracing on the swing span would require significant repair and/or do not meet load capacity requirements.

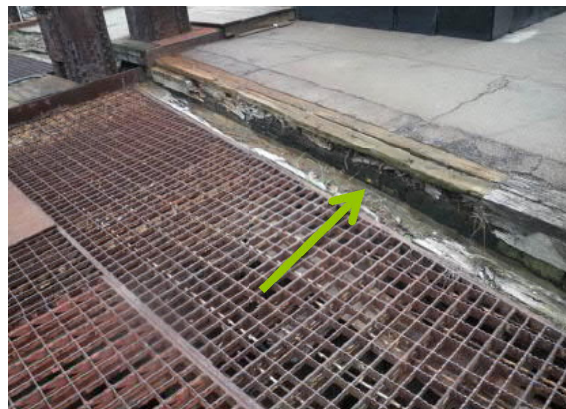
It can be challenging to fit the components back together when they are reassembled. For example, the swing span has been in the swung open position since 2014; however, in the 2013 inspection it was noted that the live load shoes for the swing span were missing. This means that since some unknown time before the 2013 inspection, the swing span has been resting solely on the drum pier in a cantilever condition. The original bridge was only designed to be cantilevered for short periods, during which times there was no live load on the bridge. Due to these conditions, during the time between when the live load shoes were removed and the pedestrians were allowed on the bridge, the load path in the truss was altered from its original design, and truss members that were designed to only carry dead load were now subjected to pedestrian live loads. Since the structure was not designed to be cantilevered for long periods of time, the swing span as a whole has experienced significant sagging. Photo 7 below shows the difference in vertical alignment between the approach span and the swing span one of the last times the bridge was closed. In fact, the alignment was so far off that timber walkways had to be constructed along the north bay to provide an even walkway for pedestrians when the bridge was still in use. Thus, work will need to be performed to ensure that once repaired and swung closed, the swing span will line up with the approach spans and that the required bridge geometry is attained.

Image 7: Vertical Alignment Differential between the Swing and Approach Span

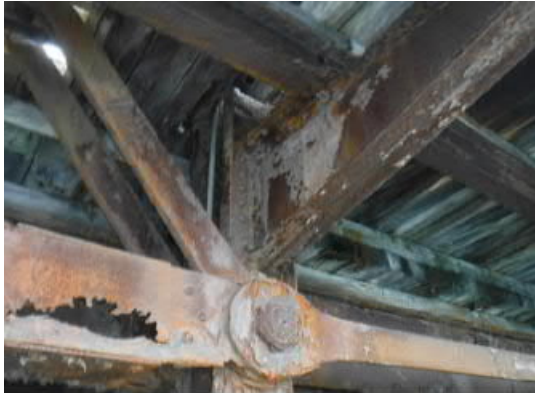
More localized examples include elongation of individual members, which may be a hindrance when reassembling the truss, as they will not line up as intended. This is particularly challenging since all of the 248 pinned connections would need to be disassembled and reassembled. These joints are complex in the sense that there are many connecting elements and plates at the joint, as seen in Images 8 & 9. The

Image 8: Typical Lower Chord Pinned Connection

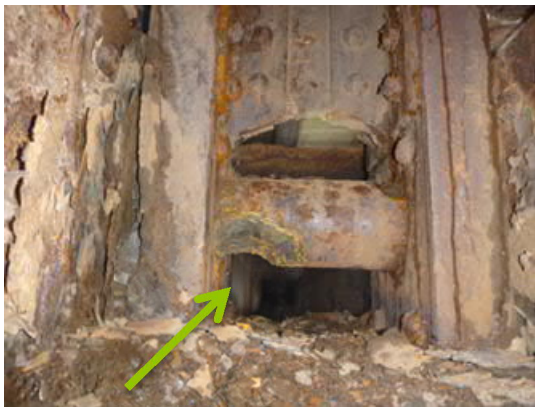
Image 10: Deterioration of the Pin

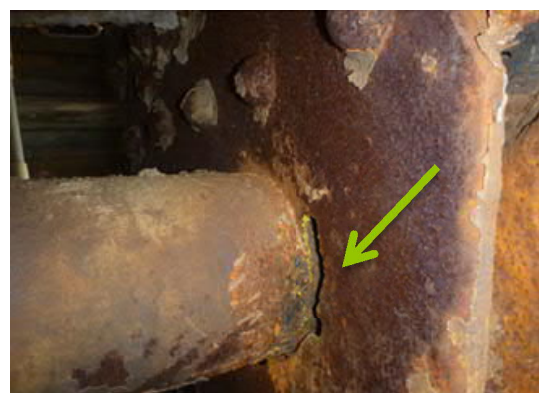
Image 11: Egging around the Pin Hole
