SOUTH END LANDMARKS DISTRICT COMMISSION APPLICATION

**Inquilinos Boricuas en Acción - Villa Victoria Center for the Arts & Preschool
85 West Newton Street, Boston, MA**

10.15.2019

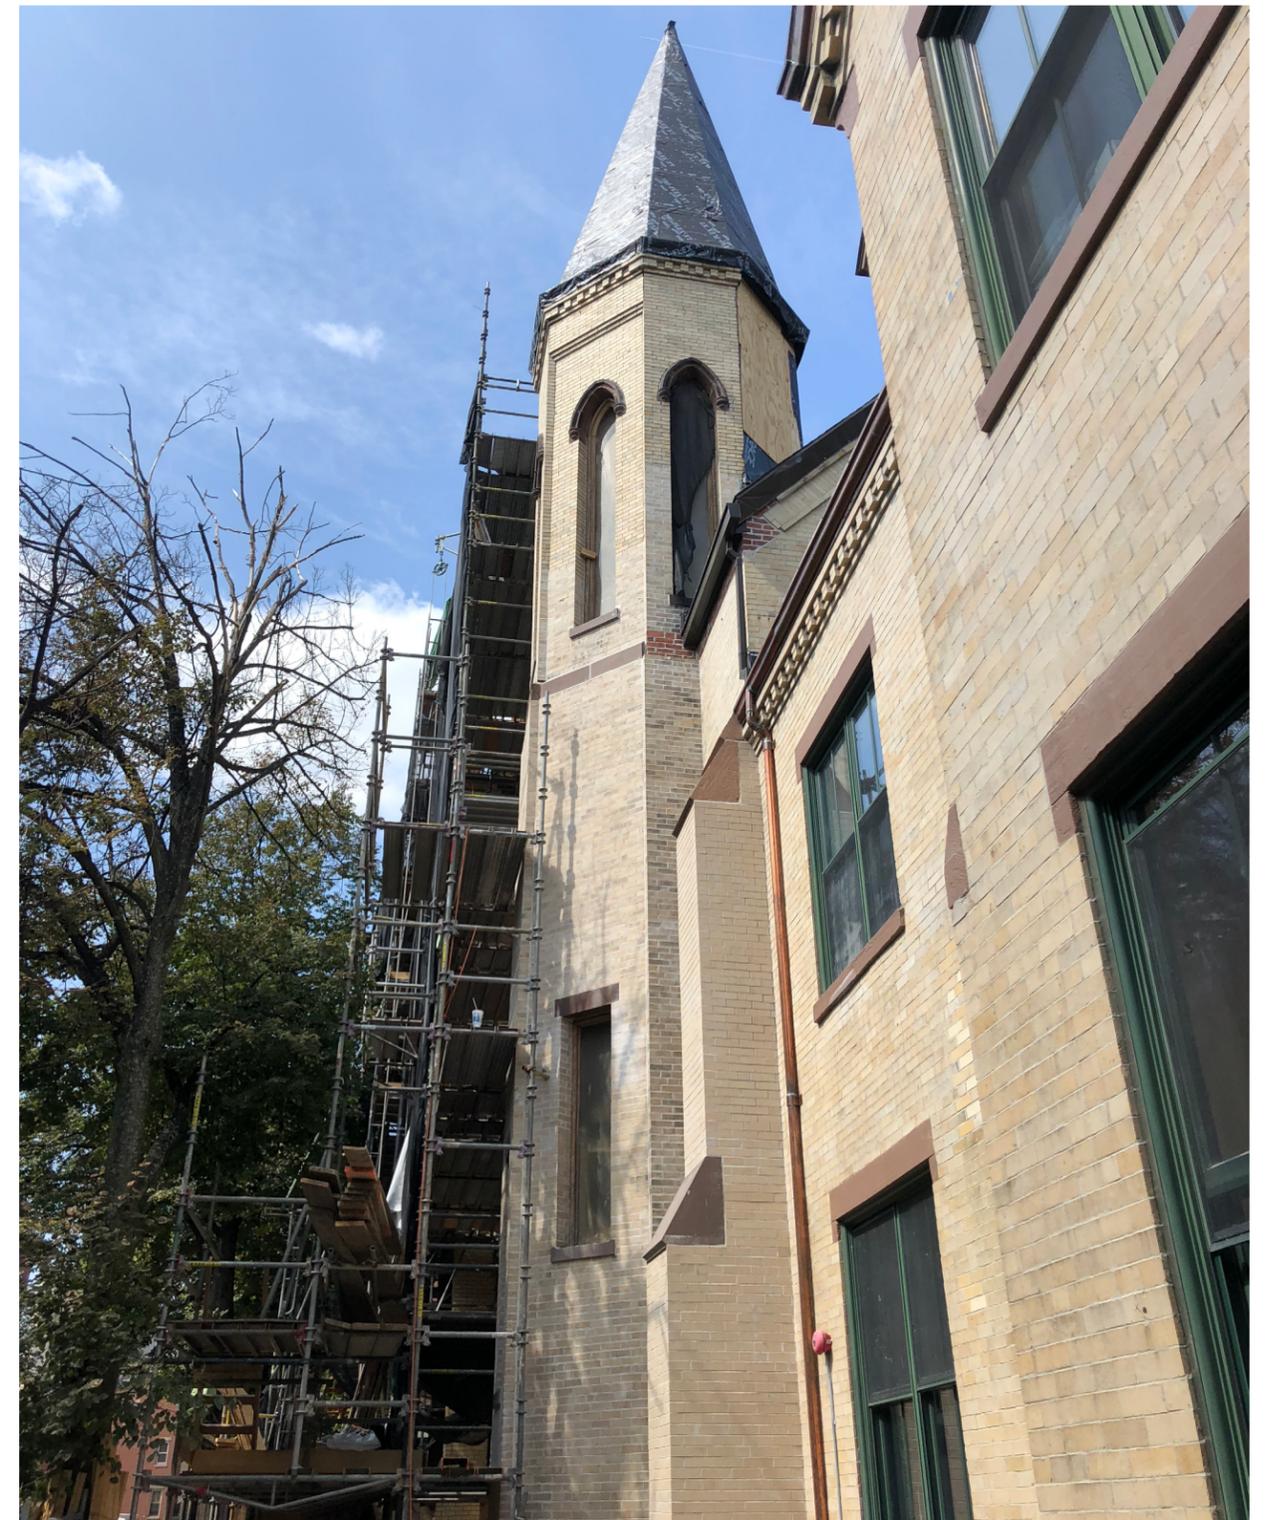
Existing condition turret with scaffolded tower base beyond

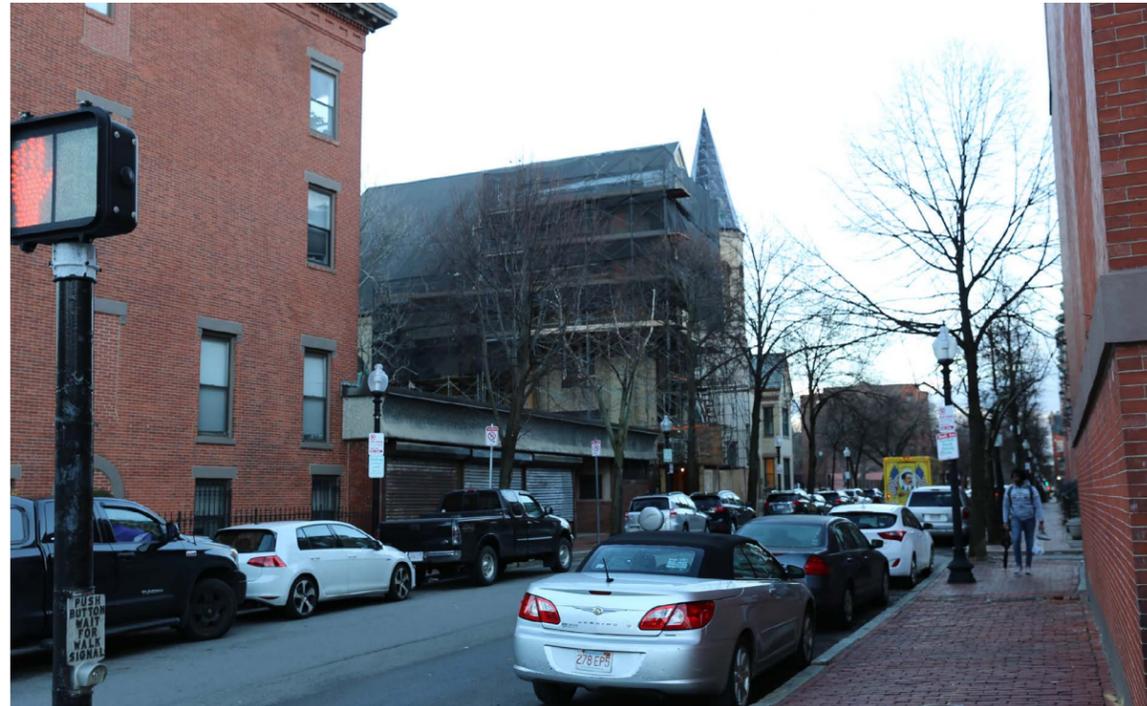
Tower base behind scaffolding from Tremont St. (Winter 2018/2019)

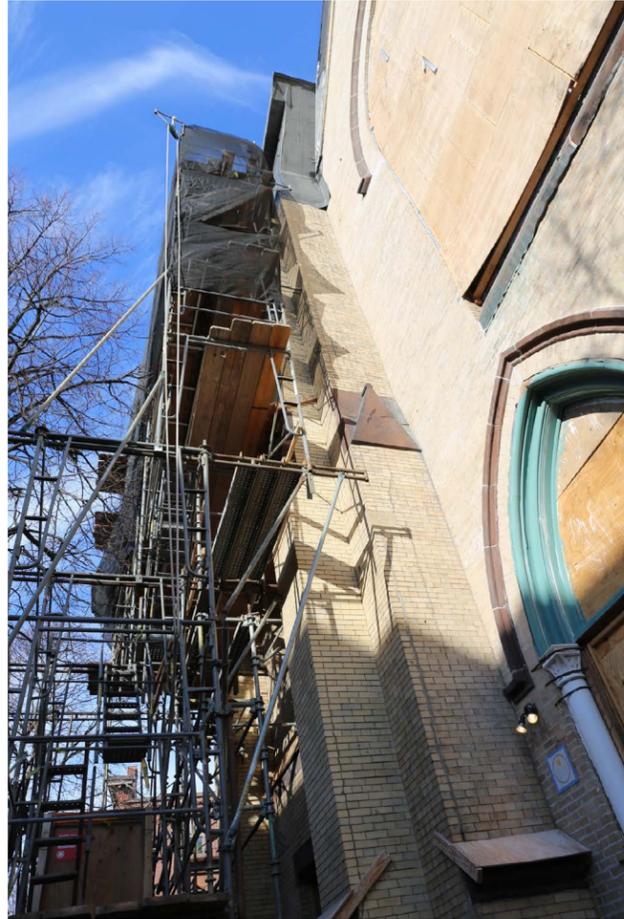
Scaffolded tower base (Spring 2019)

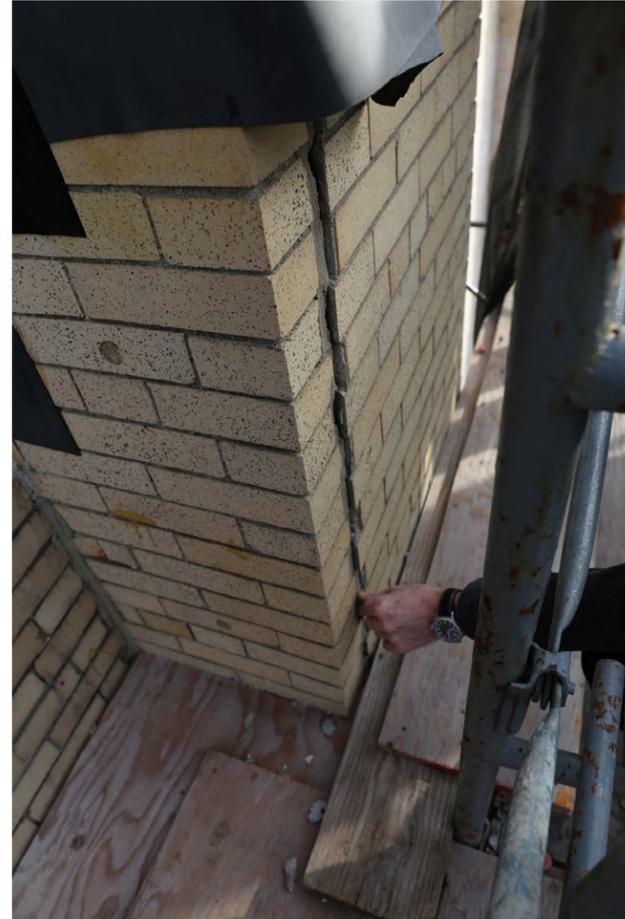
Delaminating face brick (Spring 2019)

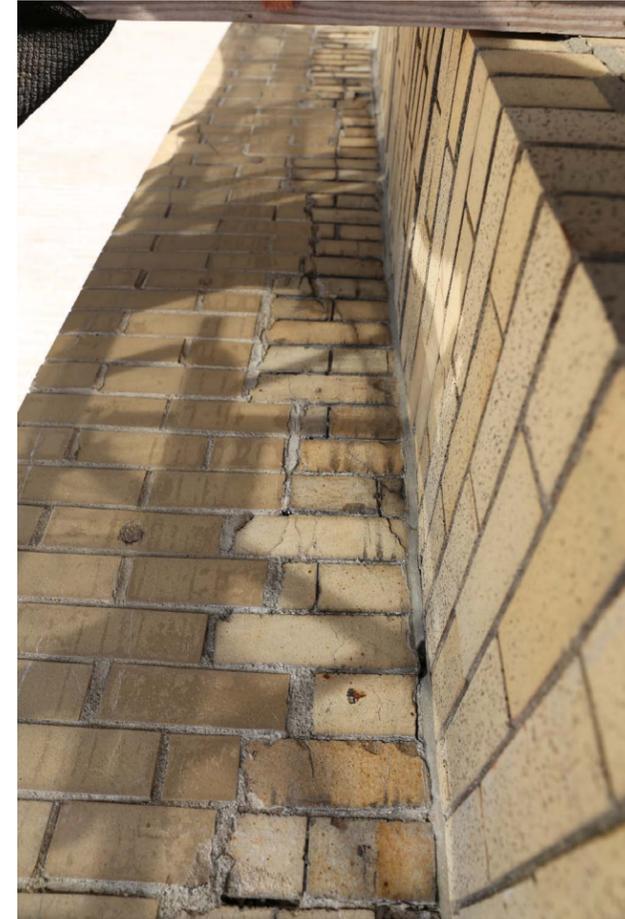
Cracks, tests and old repairs (Spring 2019)

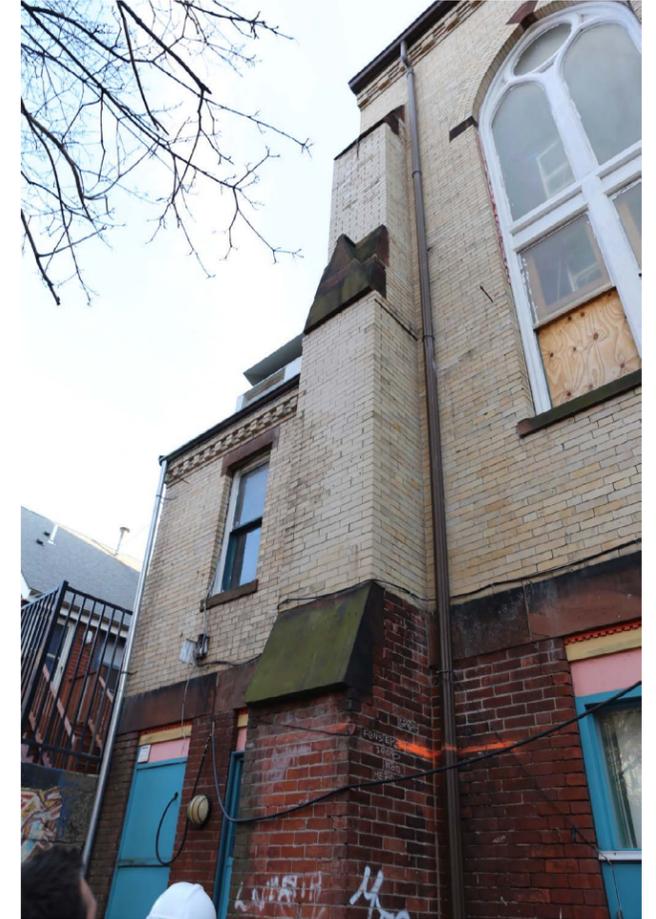
Buttress with old patches and repairs (Spring 2019)

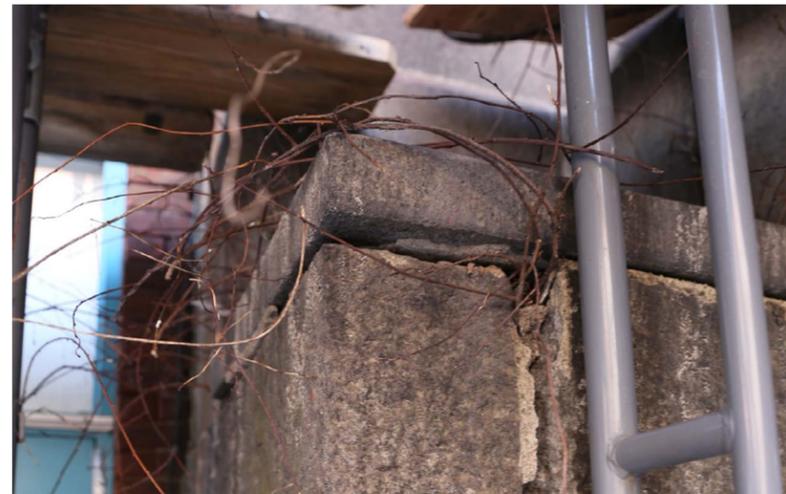
Stone displacement in granite base (Spring 2019)

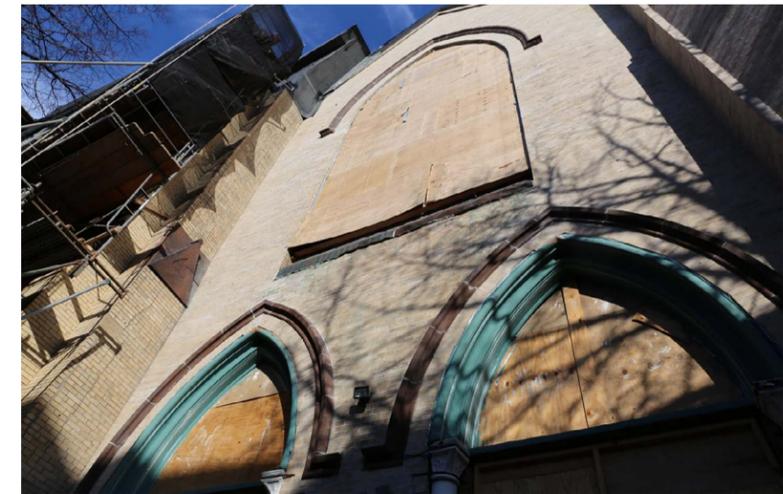
Boarded openings and mural (Spring 2019)

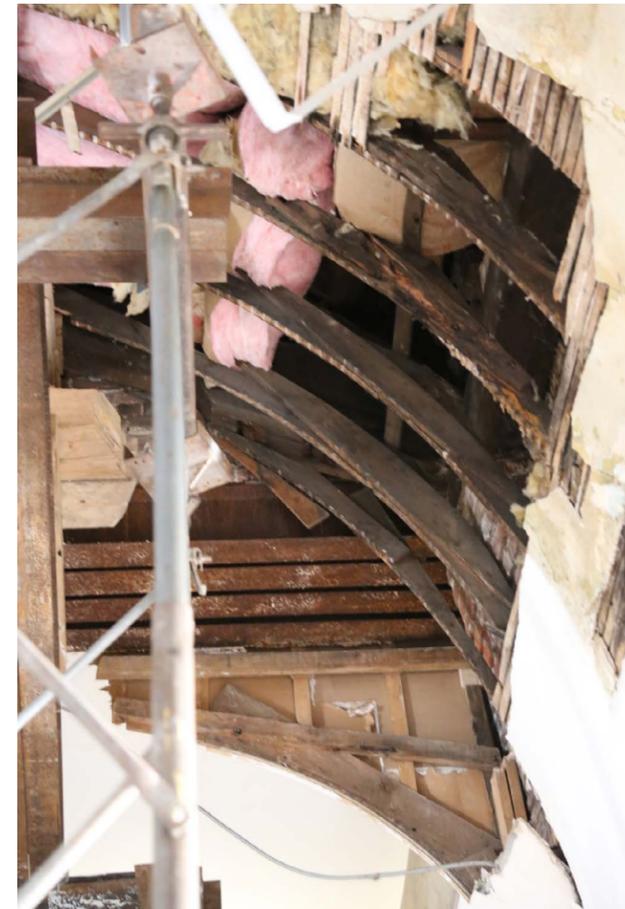
Probes and Shoring at roof framing (Spring 2019)

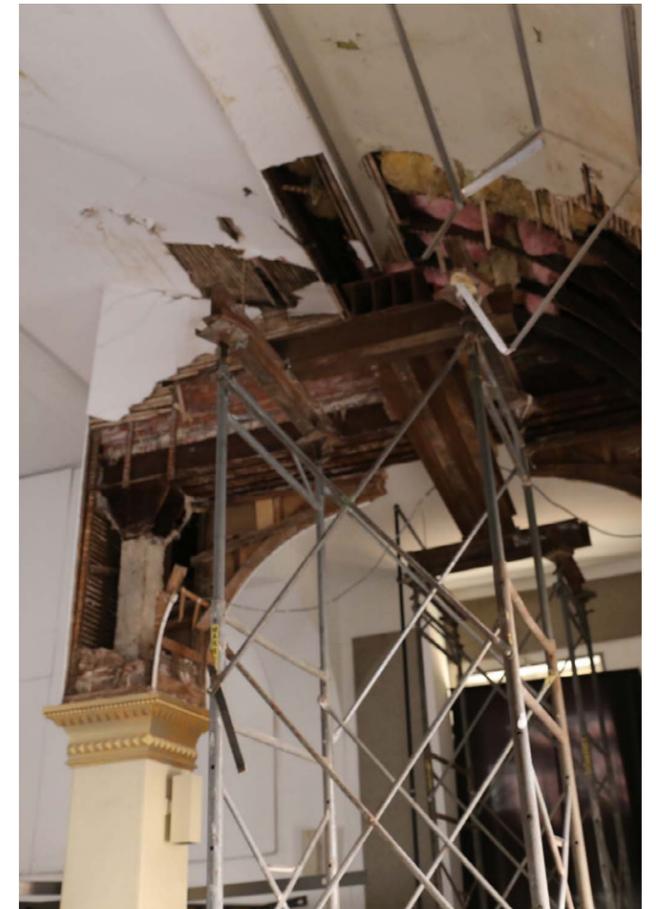
Interior tower shoring & reinforcement (Spring 2019)

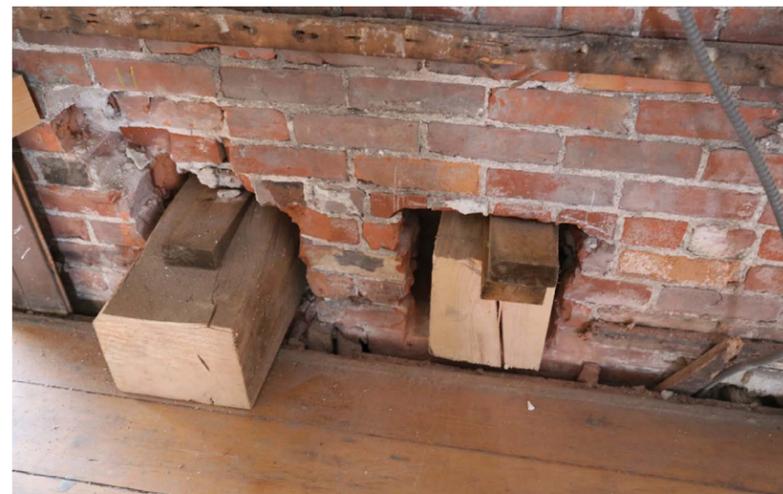
Exterior wall probes and temp support (Spring 2019)

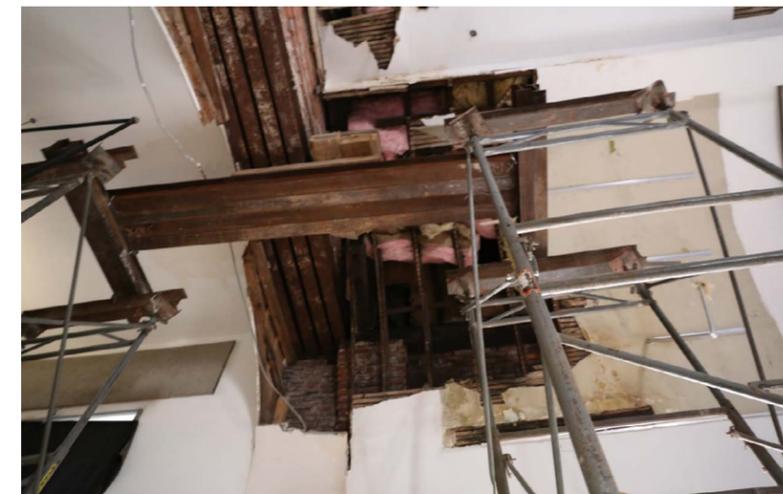
Tower and roof support shoring from below (Spring 2019)

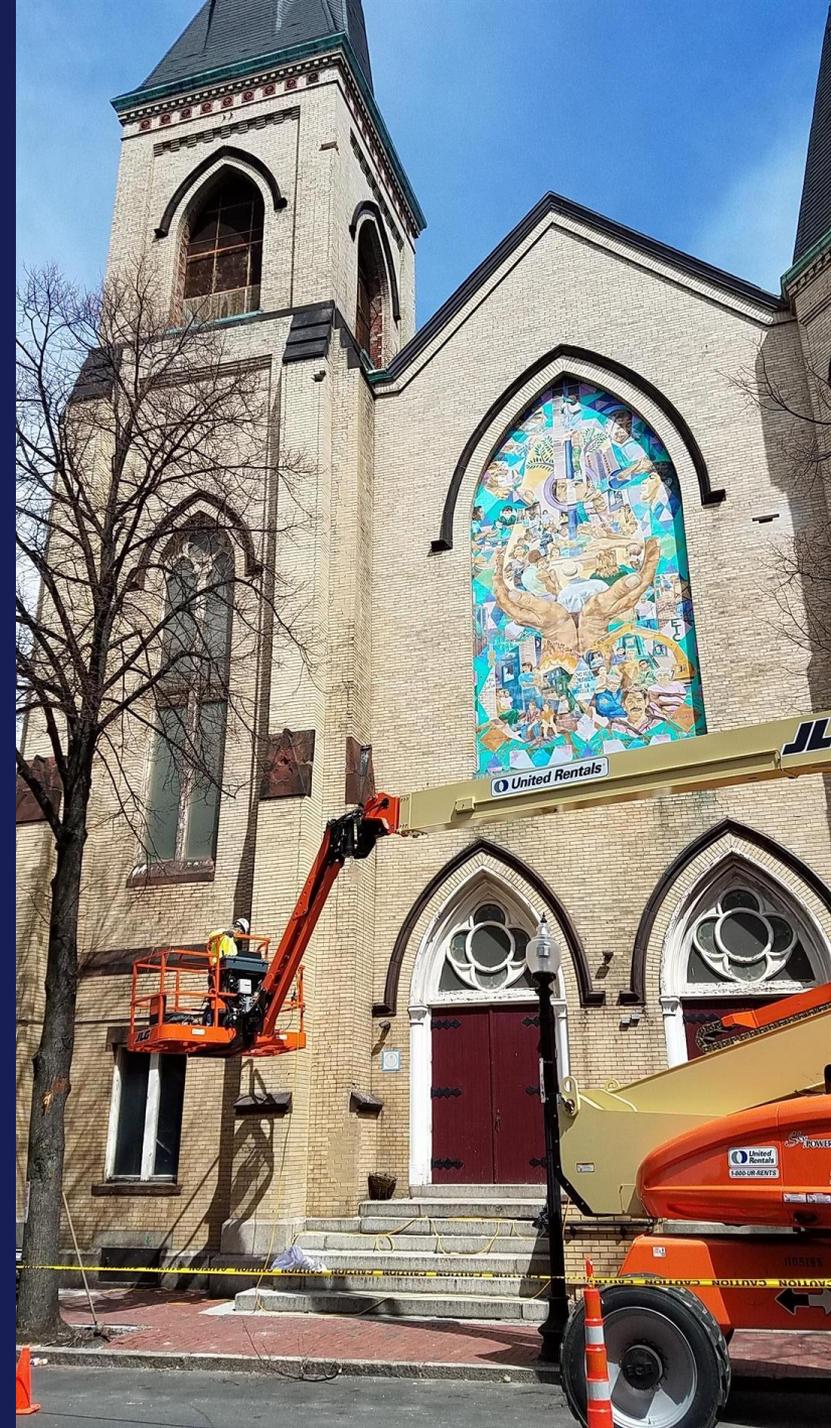
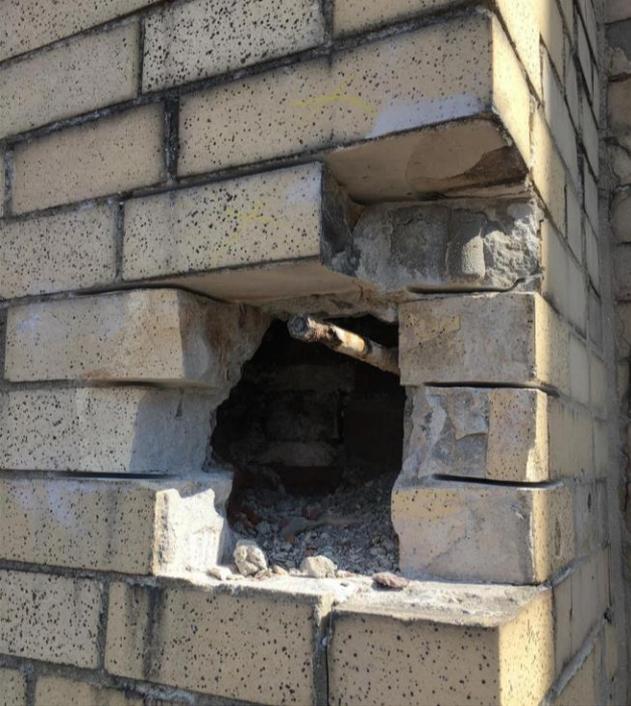
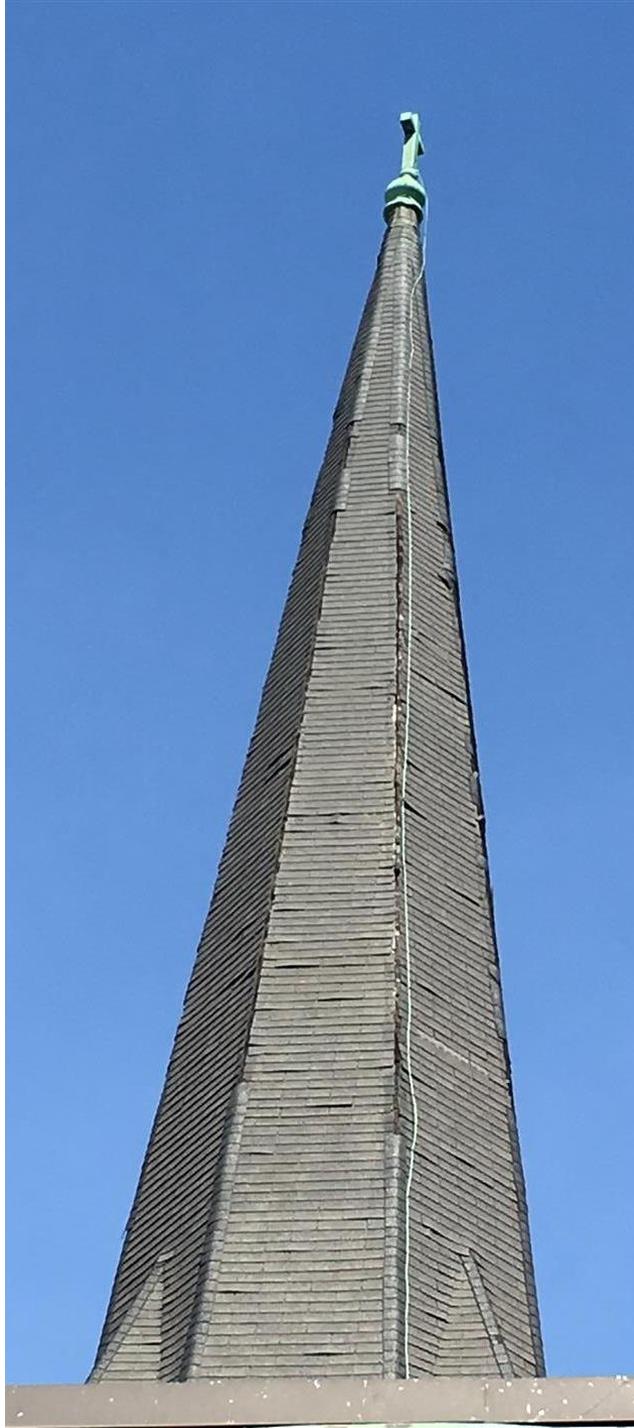
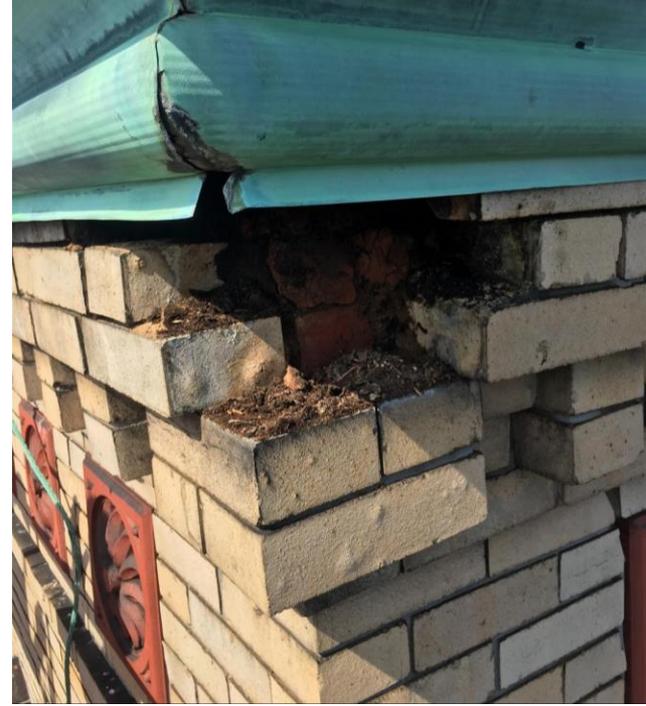
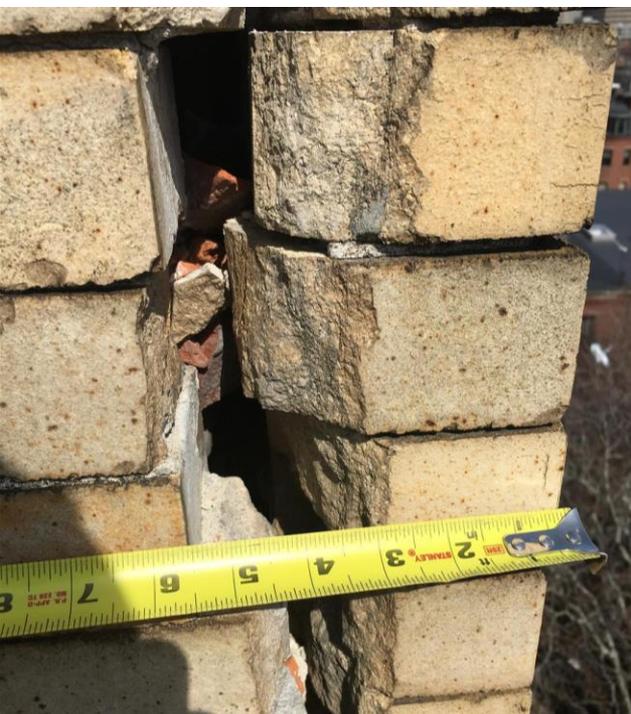
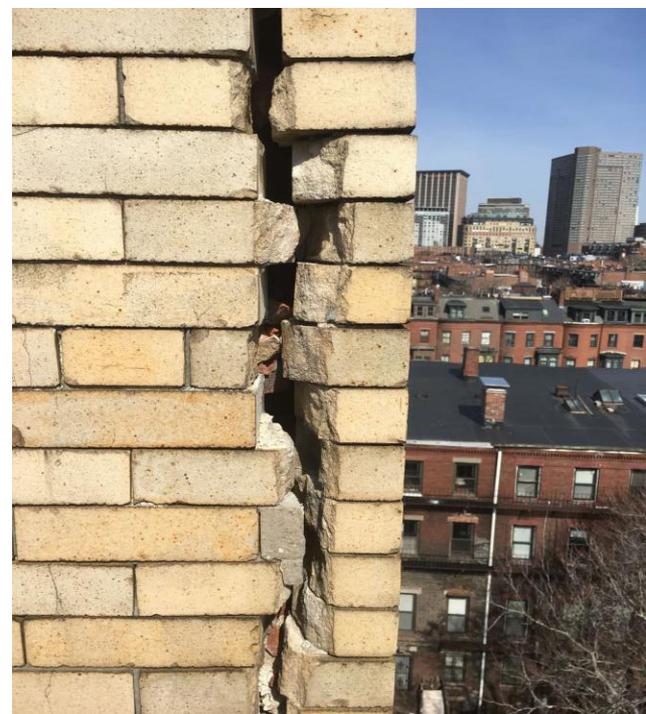
- Limited exterior evaluation
 - W. Newton St. elevation using 120' boom lift...other elevations were inaccessible
- Pilaster cracks and separation
 - Previous repair using grout pins
 - Partial rebuild outer brick only
- Loose bricks removed by hand
- Spire roof deteriorated
 - Missing shingles
 - Gaps along corners
 - Moisture damage to wood and steel members

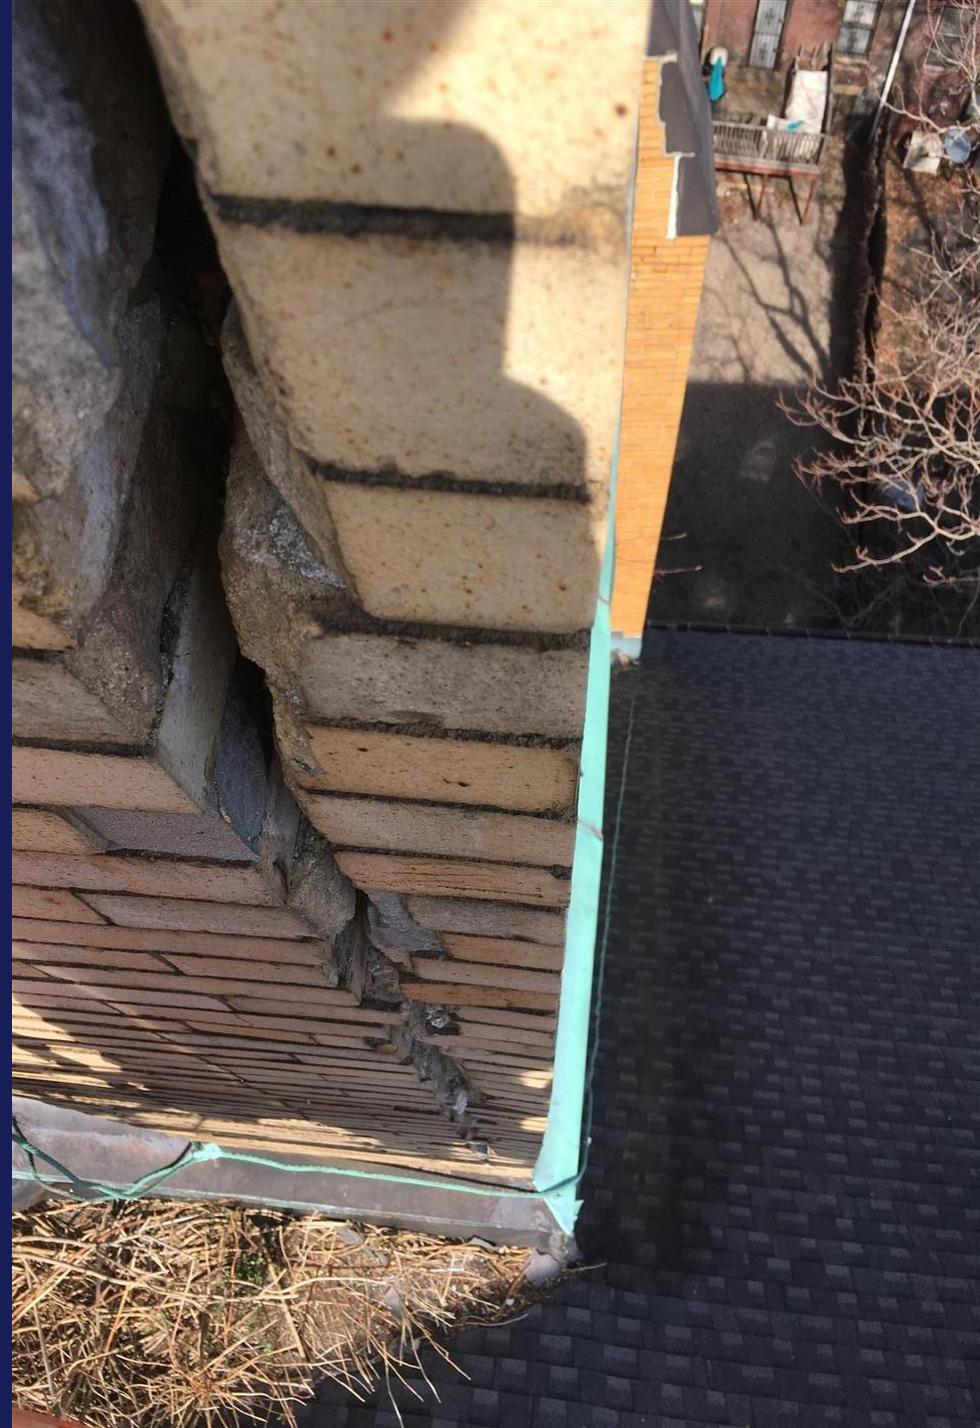
Hazardous Conditions

- **Temporary Stabilization Plan**
 - Debris netting and structural banding
- **Life safety concerns – masonry fall hazards**
 - Overhead protection W. Newton St. sidewalk and alley
 - Temporary closure of hall, lobby, restrooms
- **Team elected to begin design of permanent repairs**

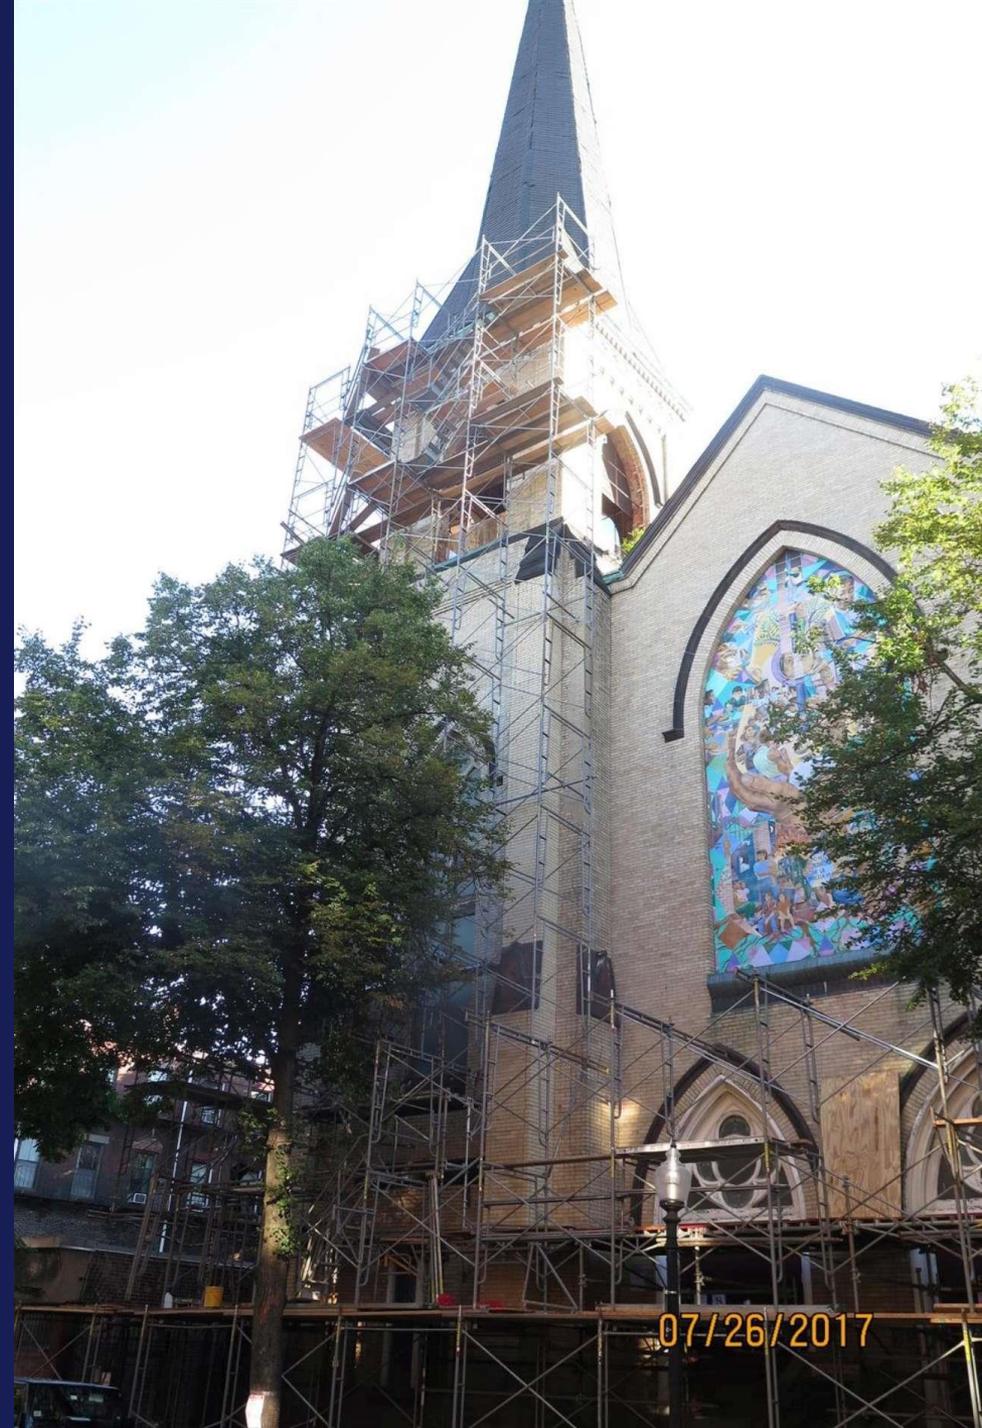
Additional Interior & Exterior Tower Eval.

- Test Cuts – interior of tower (no access to exterior – unsafe scaffold)
- deteriorated masonry within belfry
- Rotted ends of pocketed floor joists
- Pocketed steel lintels corroded
- Team made decision to proceed with Phase 1A design (replace spire and upper tower walls) rather than wait for additional exterior test cuts when scaffolding was deemed safe to access.

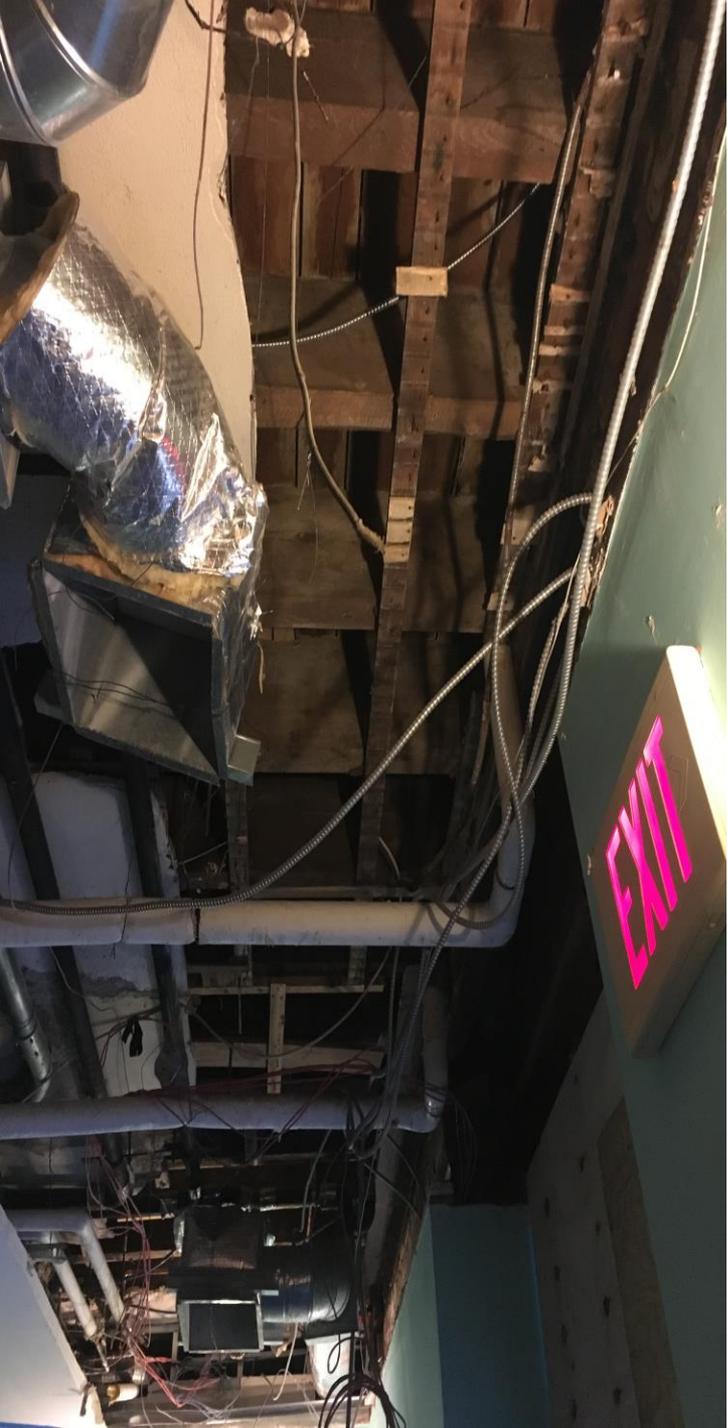
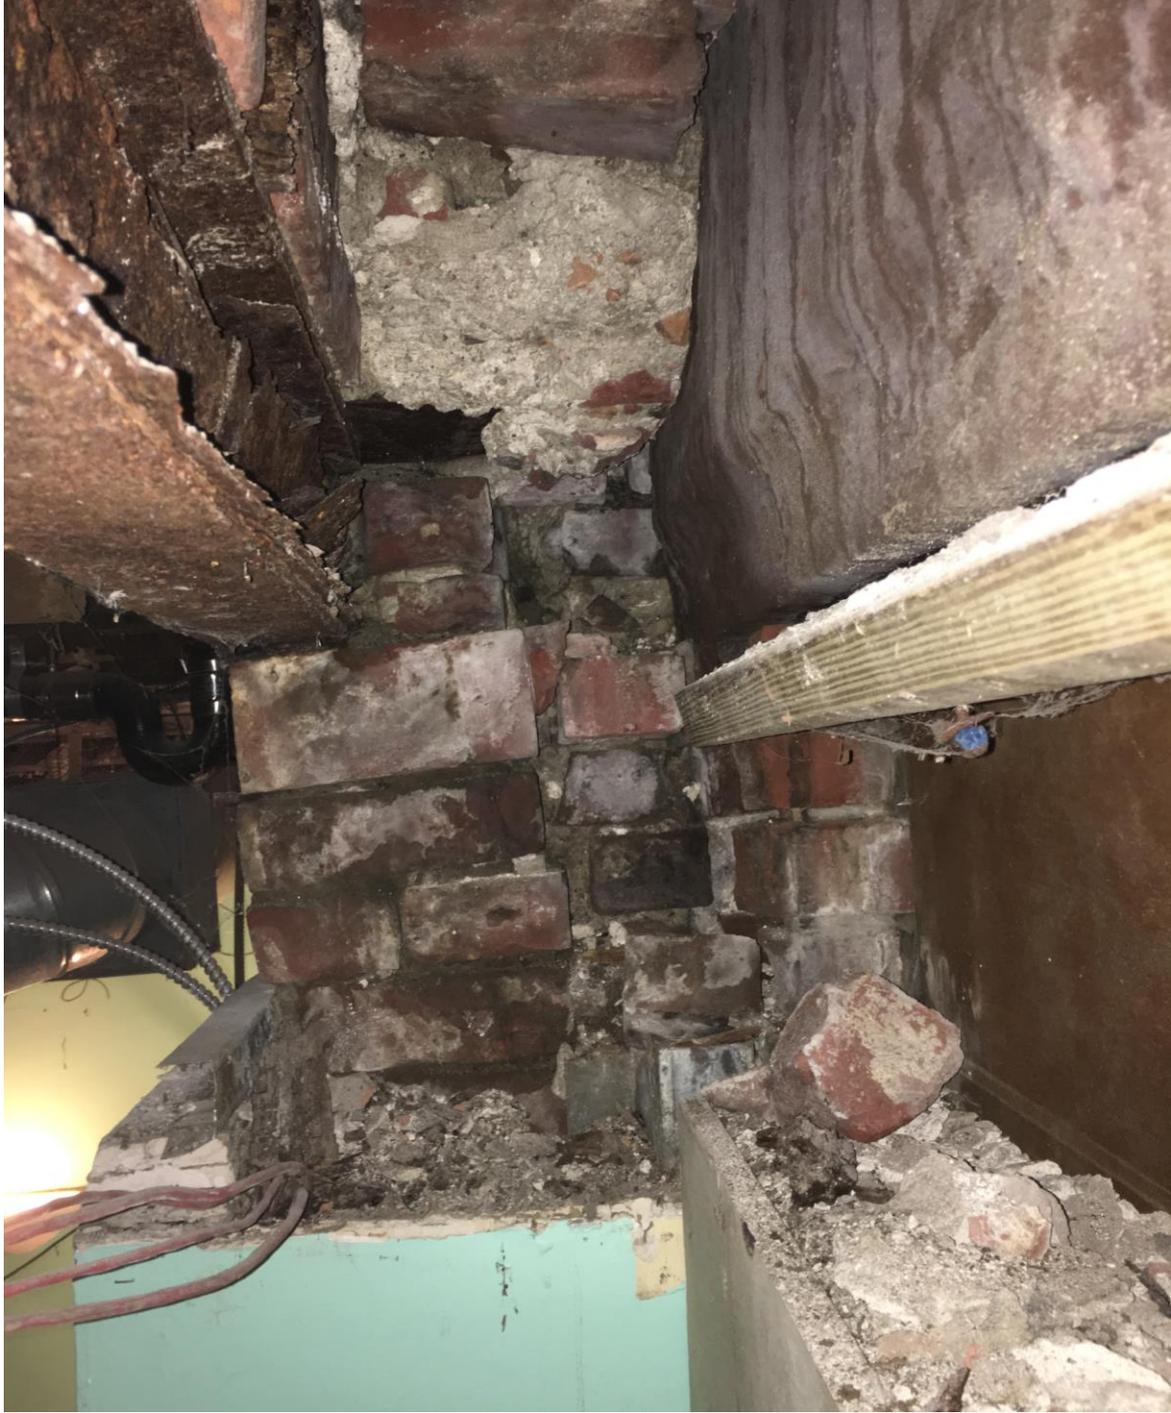
North Wall Damage Discovered

- Scaffolding installed along north elevation
 - Discovered debris clogged primary roof drain had caused extensive damage to wall below
 - Gale initiated GPR scanning followed by additional test cuts which identified separation between the inner and outer courses
 - Mortar washout and deteriorated conditions full height of wall below clogged drain
 - Rotted timber and steel lintel with deteriorated masonry above preschool egress door to alley
 - Severely corroded steel beam supporting floor joists
 - Shoring required
 - Adjacent classroom closed

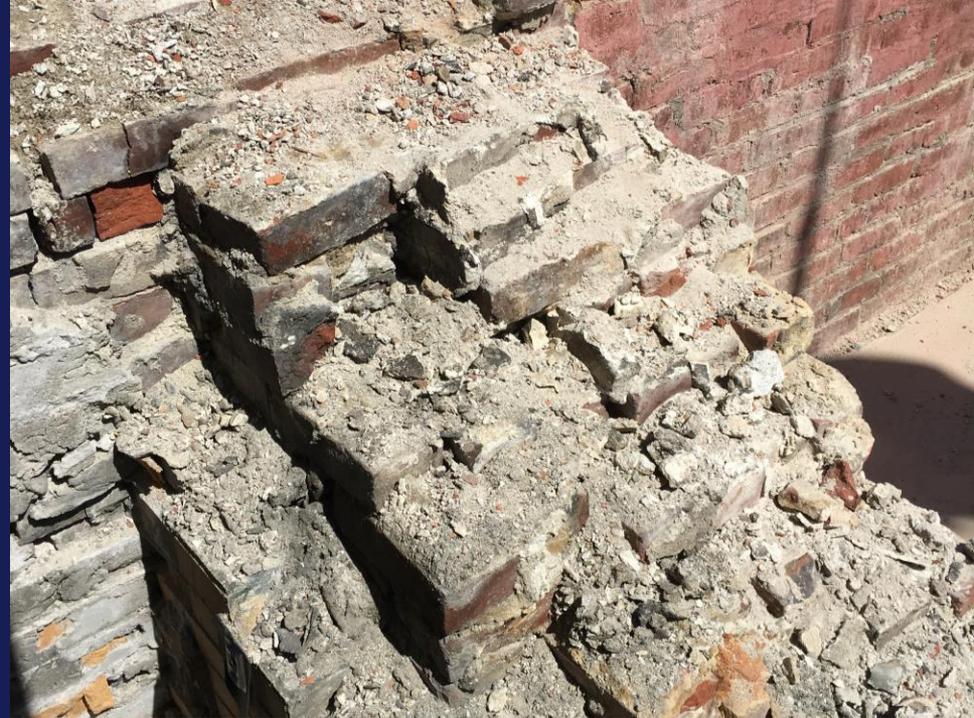
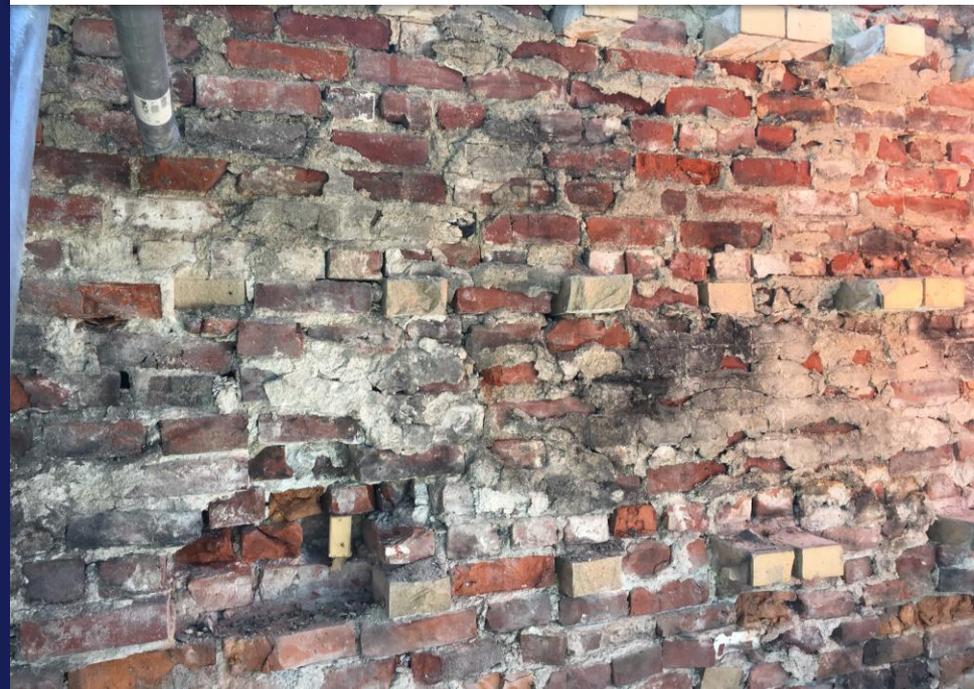
Tower Demolition

- **Poor masonry conditions still exist**
 - Demolition hammers loosen large areas of wall
 - Bricks removed easily by hand
 - Large sections of blonde brick “peeled” away with pry-bar...snapped headers
 - Severely deteriorated joint mortar
- **SGH to provide 2nd opinion on wall integrity and validate Gale’s findings:**
 - SGH agreed with Gale’s assessment that masonry deterioration too extensive to support weight of new belfry and spire

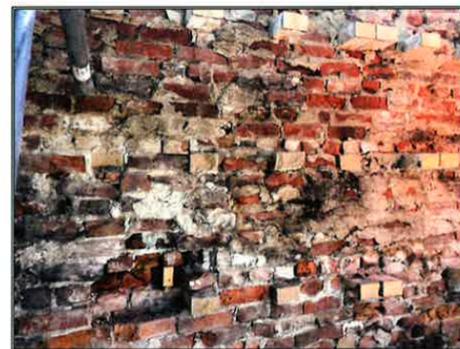
On May 8, 2018, Gale again visited the site to observe Shawmut's method of demolition using hand tool techniques and to review the underlying condition of the undisturbed inner red brick wythes. Following the removal of approximately seven feet (7') of blonde brick veneer along the north tower wall using this technique, it was revealed that more than half of the blonde brick headers were snapped or unbonded.

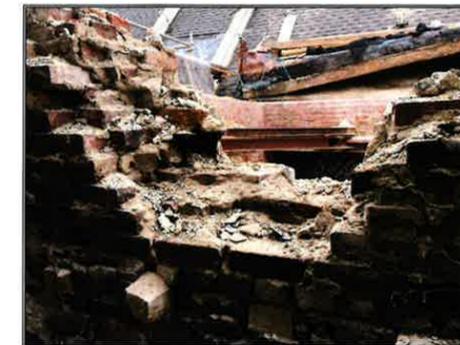
At many locations, inner red brick wythes could be removed by hand and were found to have little mortar bond between courses.

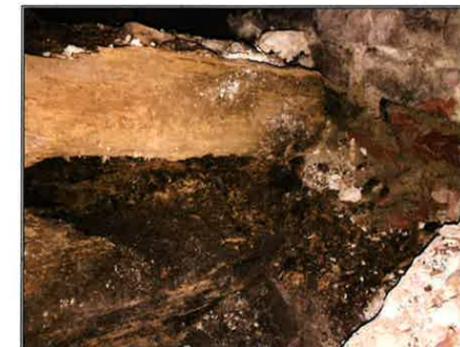
On May 9, 2018, Gale observed the truss bearing condition adjacent to the tower, at the main building roof eave, which was previously inaccessible, and discovered multiple structural deficiencies. The end of the timber roof truss appeared to be severely deteriorated, with significant section loss where the top and bottom chords meet at the truss bearing point.

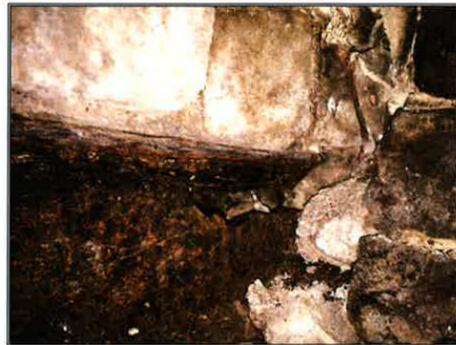
Additionally, adjacent to the truss, a portion of the structural steel lintel supporting the entire weight of the remaining east tower masonry wall was observed to be severely deteriorated. The visible portion of the flanges and web of the lintel was observed to have significant section loss, including a hole through the web at its end.

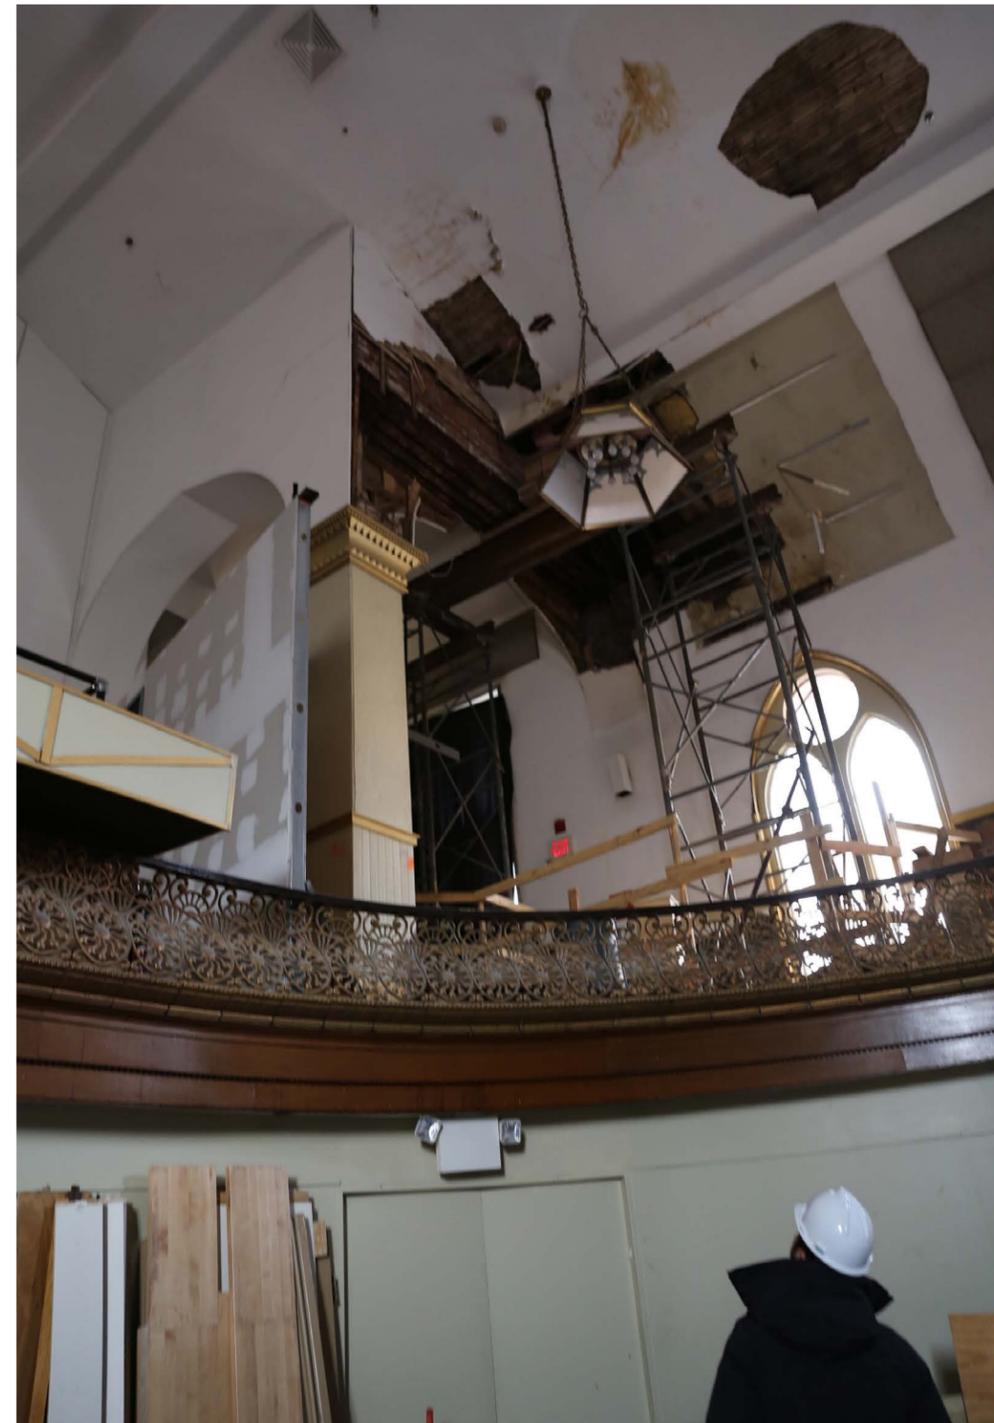
Existing condition photograph of interior demolition and temporary shoring
