EXISTING NORTHERN AVENUE BRIDGE EVALUATION MEMO

The Northern Avenue Bridge over the Fort Point Channel in Boston MA was originally constructed between 1905 and 1908 and has been repaired / rehabilitated numerous times throughout the years. Due to severe deterioration, the bridge was closed to vehicular traffic in 1997 and closed to pedestrian traffic in 2014. The 2014 closure was prompted by a new revelation that several floor beams supporting the pedestrian walkway had a calculated live load rating capacity of zero tons. This finding was the result of an inspection and rating effort provided by TranSystems. Since then, the bridge has been out of use and left in the swung open positon.

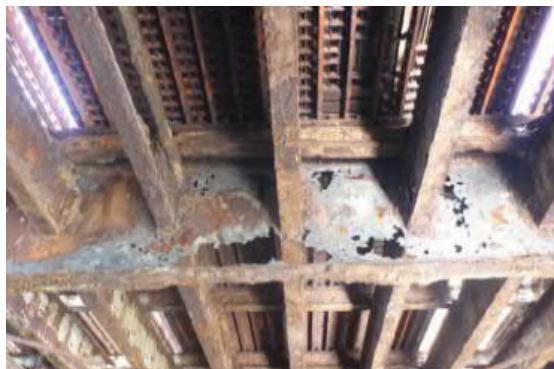
The deck and floor system, including all deck and structural framing elements as well as the sidewalk cantilevers and lower lateral bracing, were inspected in 2013. These members were not re-inspected in 2017 based on the severity of the condition noted during the previous inspection. The deck and floor system were found to be in critical condition due to widespread deterioration, and a portion of the sidewalk cantilevers were noted as a risk for imminent failure at the time of the 2013 report. Refer to Images 1 and 2 below, showing sample floor beam and stringer conditions.

Image 1: 100% Section Loss in a Swing Span Floorbeam

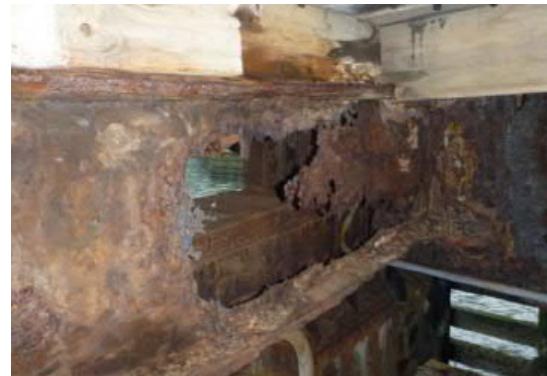
Image 2: 100% Section Loss in an Approach Span Stringer

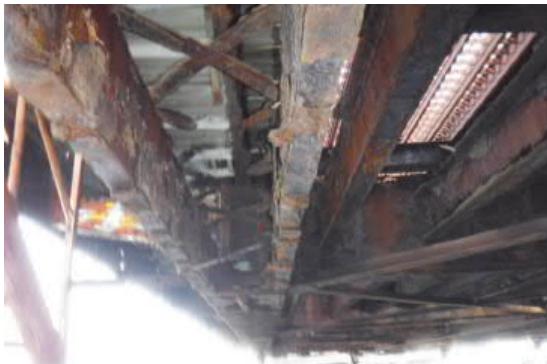
The truss members themselves varied in condition based on their location along the bridge and by element. The lower chord members exhibit moderate-to-severe corrosion and deterioration (up to 100% section loss) concentrated around the ends of the members near the pin assemblies (See Image 3). The upper chord members are observed to be in generally satisfactory condition, with a few scattered deficiencies and corrosion with no significant visible deterioration (See Image 4).

Image 3: Severe Deterioration and 100% Loss of Lattice Bracing in the Swing Span Lower Chord

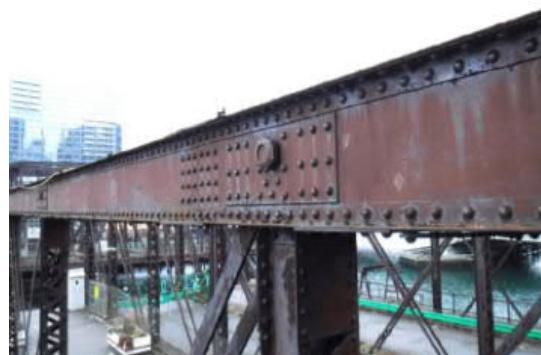
Image 4: Typical Top Chord Member in the Approach Spans

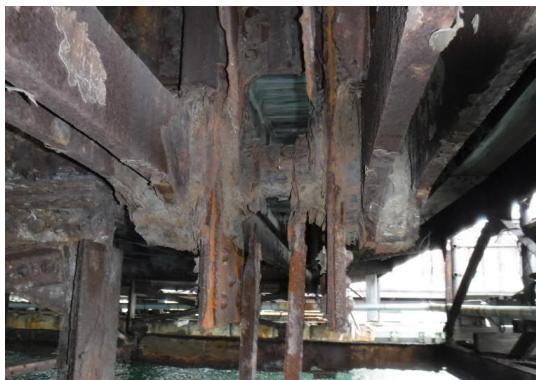
The condition of the vertical truss members vary along their length, with the areas below the deck possessing moderate-to-advanced corrosion and the areas above the deck in generally satisfactory condition with minor deficiencies and scattered corrosion. In general, the portions of the verticals which extend below the deck and pin joint are severely deteriorated, as seen in Image 5.

Image 5: Severe Deterioration of the Verticals Below the Deck and Pin

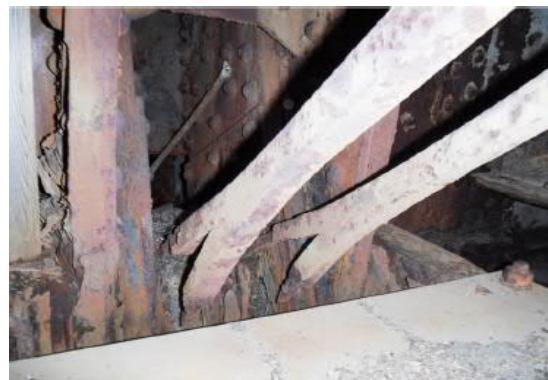
Similar to the verticals, the diagonal truss members generally show moderate-to-advanced corrosion below the deck level, especially concentrated around the pin joint areas. An example of section loss of the diagonals at the lower pin joint can be seen in Image 6.

Image 6: 100% Section Loss of Eye Bars Diagonals in the Swing Span

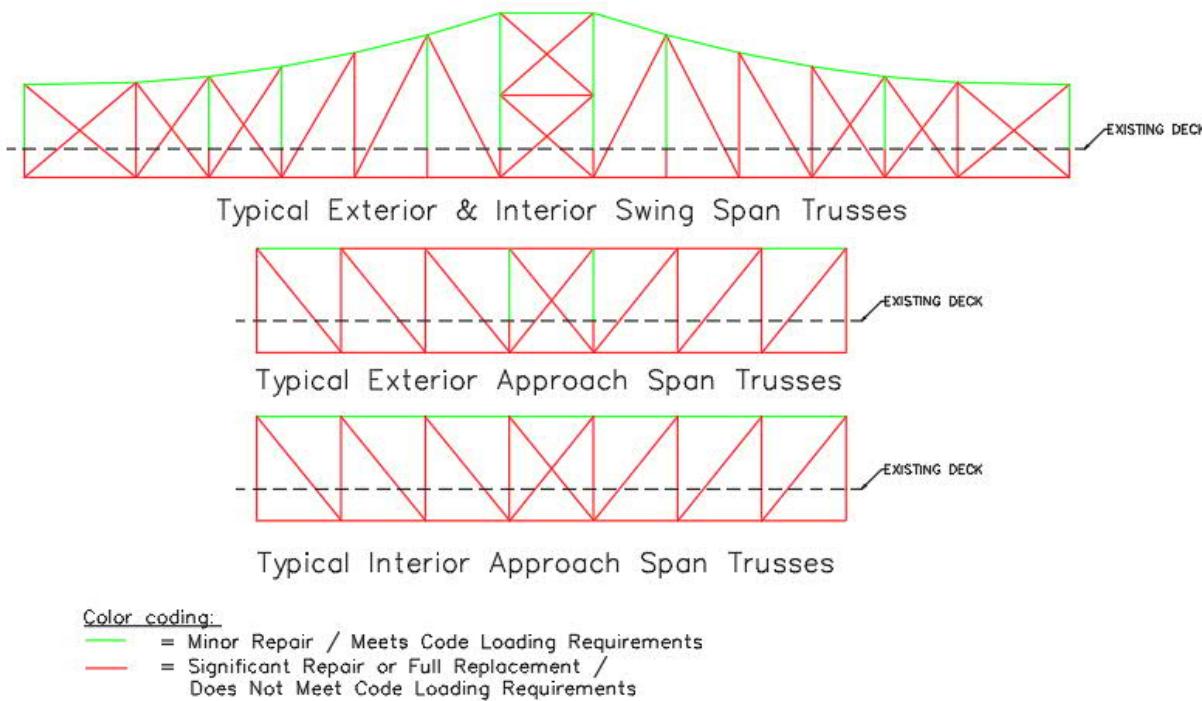
Combining the results of the condition inspection and structural analysis, the elements of the bridge which may be potentially re-used in a rehabilitated structure have been evaluated. As previously discussed, the floor system is beyond repair and would require replacement in any rehabilitation scenario. Figure 1 below graphically shows the summary of the results of the combined capacity and condition analysis for the primary truss elements. The elements depicted in red indicate members which would need significant repair and/or do not meet current load capacity requirements. Members depicted in green would meet current load capacity requirements but may also require minor repairs. The diagram is shown for a typical truss in the structure; there is some minor variation among the spans and trusses. Overall, based on existing conditions and structural analysis, 75% of the exterior and interior swing span trusses, 90% of the exterior approach span trusses and 75% of the interior approach span trusses primary members would require significant repair and/or do not meet load capacity requirements. For the secondary truss elements approximately 25% of the upper sway bracing on the approach spans and less than 20% of the upper sway bracing on the swing span would require significant repair and/or do not meet load capacity requirements.

Figure 1: Truss Based on Combined Condition and Capacity

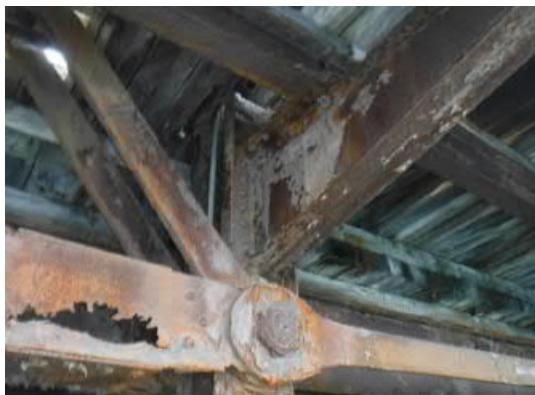
More localized examples include elongation of individual members, which may be a hindrance when reassembling the truss, as they will not line up as intended. This is particularly challenging since all of the 248 pinned connections would need to be disassembled and reassembled. These joints are complex in the sense that there are many connecting elements and plates at the joint, as seen in Images 8 & 9. The

Image 8: Typical Lower Chord Pinned Connection

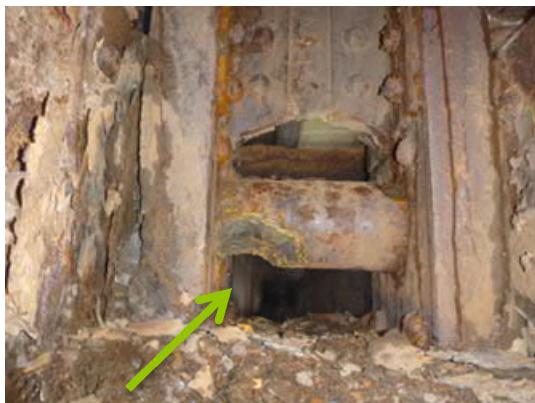
Image 10: Deterioration of the Pin

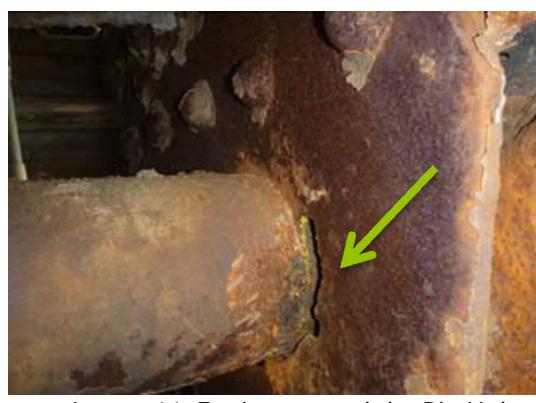
possibility that all of the pieces will not fit back together properly after repairs are made is highly probable. Given the historical cyclic loading of the bridge, it is also possible that the holes in the members that encase the pin have experienced "egging" and are no longer uniform circles, and thus do not provide the same constraints as when they were originally designed. Examples of deformation in the pin and the surrounding members are observed in Images 10 & 11 below. In addition to repairing deterioration in the member cross sections, distortion of the pin holes would also need to be addressed and corrected in order to restore the structural integrity of the pinned connections. Such repairs could potentially be achieved via cover plates, splices, or full member replacements, all of which have the potential to further complicate the joint, particularly in regard to geometric constraints.

Image 11: Egging around the Pin Hole
