Project Notification Form

Northern Avenue Bridge Project

City of Boston Public Works Department

July 25, 2019

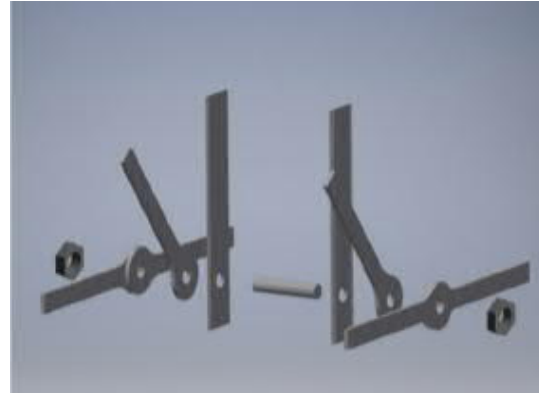
Image 9: Model of a Disassembled Pin Connection

More localized examples include elongation of individual members, which may be a hindrance when reassembling the truss, as they will not line up as intended. This is particularly challenging since all of the 248 pinned connections would need to be disassembled and reassembled. These joints are complex in the sense that there are many connecting elements and plates at the joint, as seen in Images 8 & 9. The

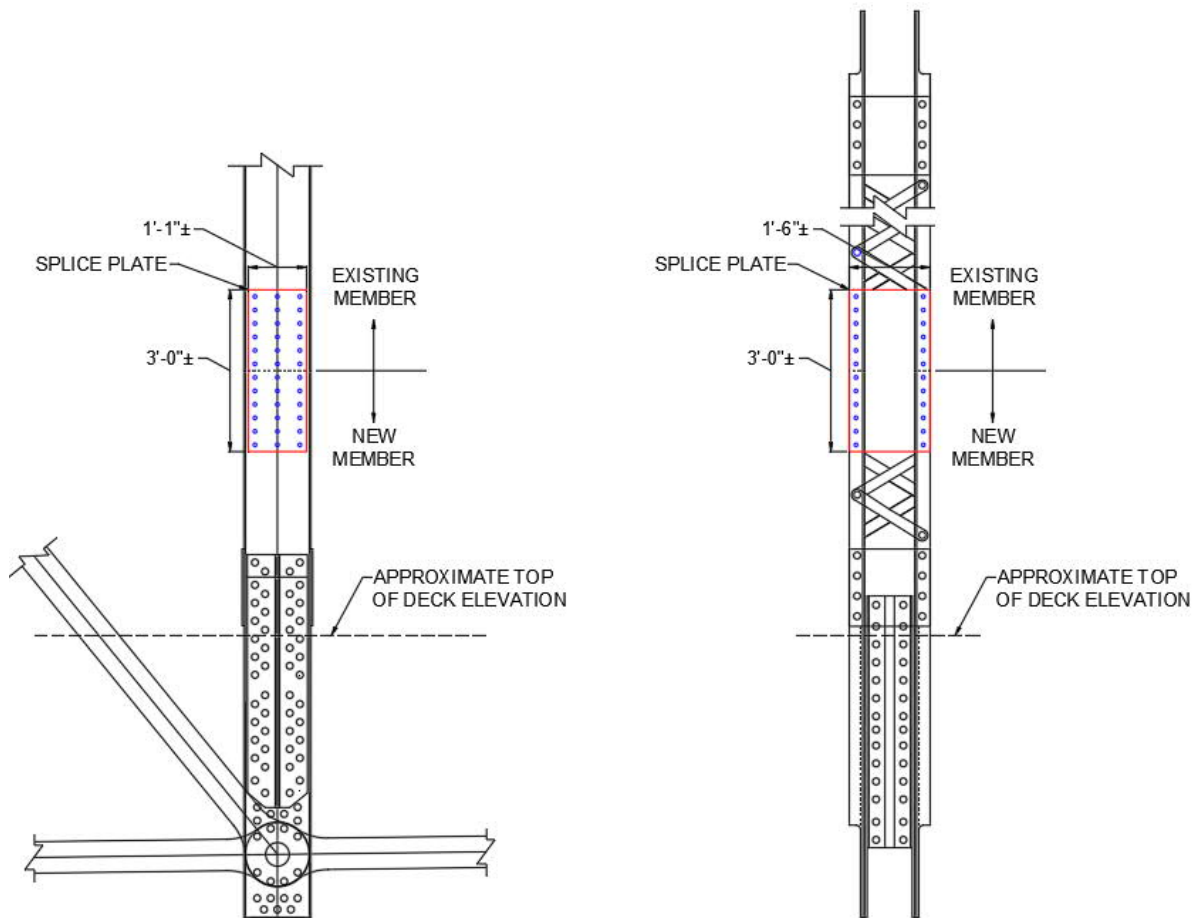
Figure 2: Approximate Splice Detail

A bolted splice is a feasible alternative to a welded splice. Due to the intricate lattice work on the verticals, not only would a splice of the verticals need to be sized for capacity, but it would also need to be designed around the existing lattice pattern. Due to the combined axial and flexural effects on the verticals and the geometric limits based on lattice location, larger splice plates are required. The approximate location of the splice on the vertical truss members would be just above the deck level. A preliminary splice detail for a sample vertical is presented in Figure 2 below.
