SOUTH END LANDMARKS DISTRICT COMMISSION APPLICATION

**Inquilinos Boricuas en Acción - Villa Victoria Center for the Arts & Preschool
85 West Newton Street, Boston, MA**

10.15.2019

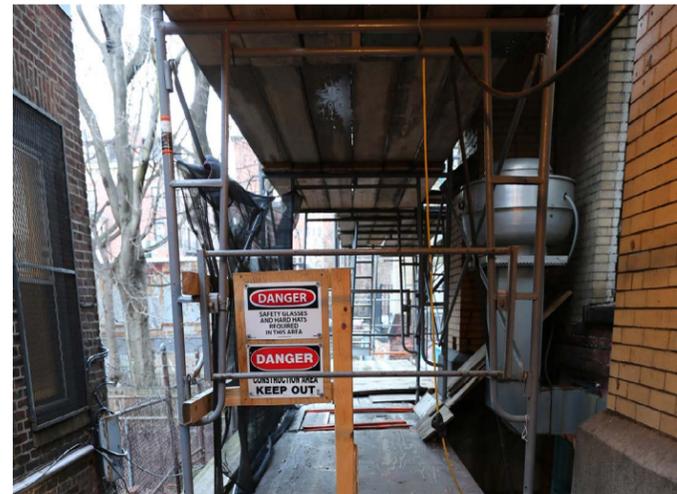
Protective scaffolding in alleyway (Spring 2019)

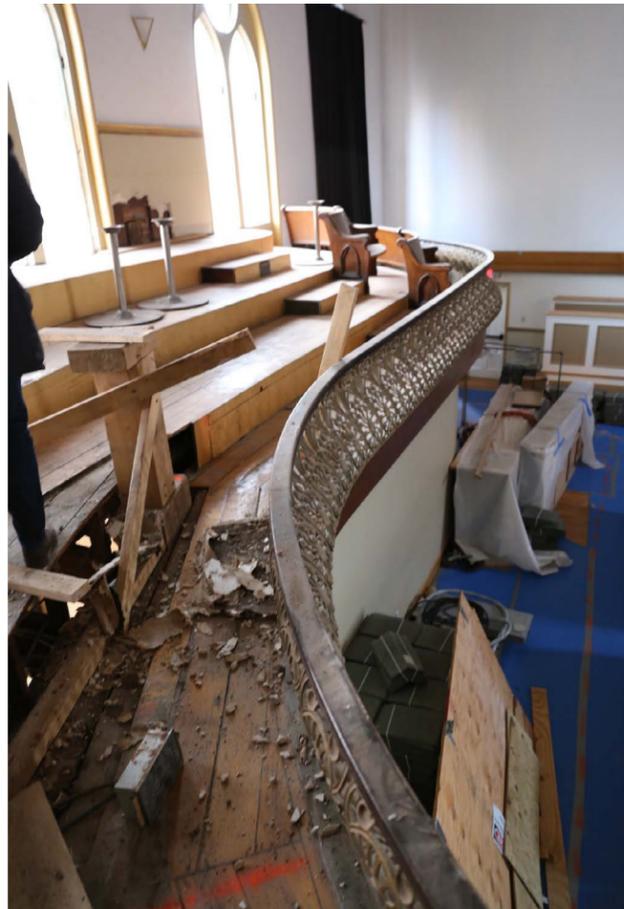
Existing balcony (Spring 2019)

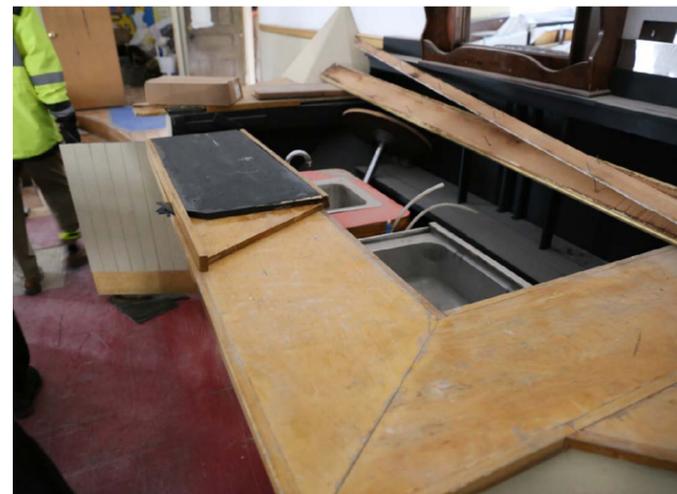
Interior finishes and millwork (Spring 2019)

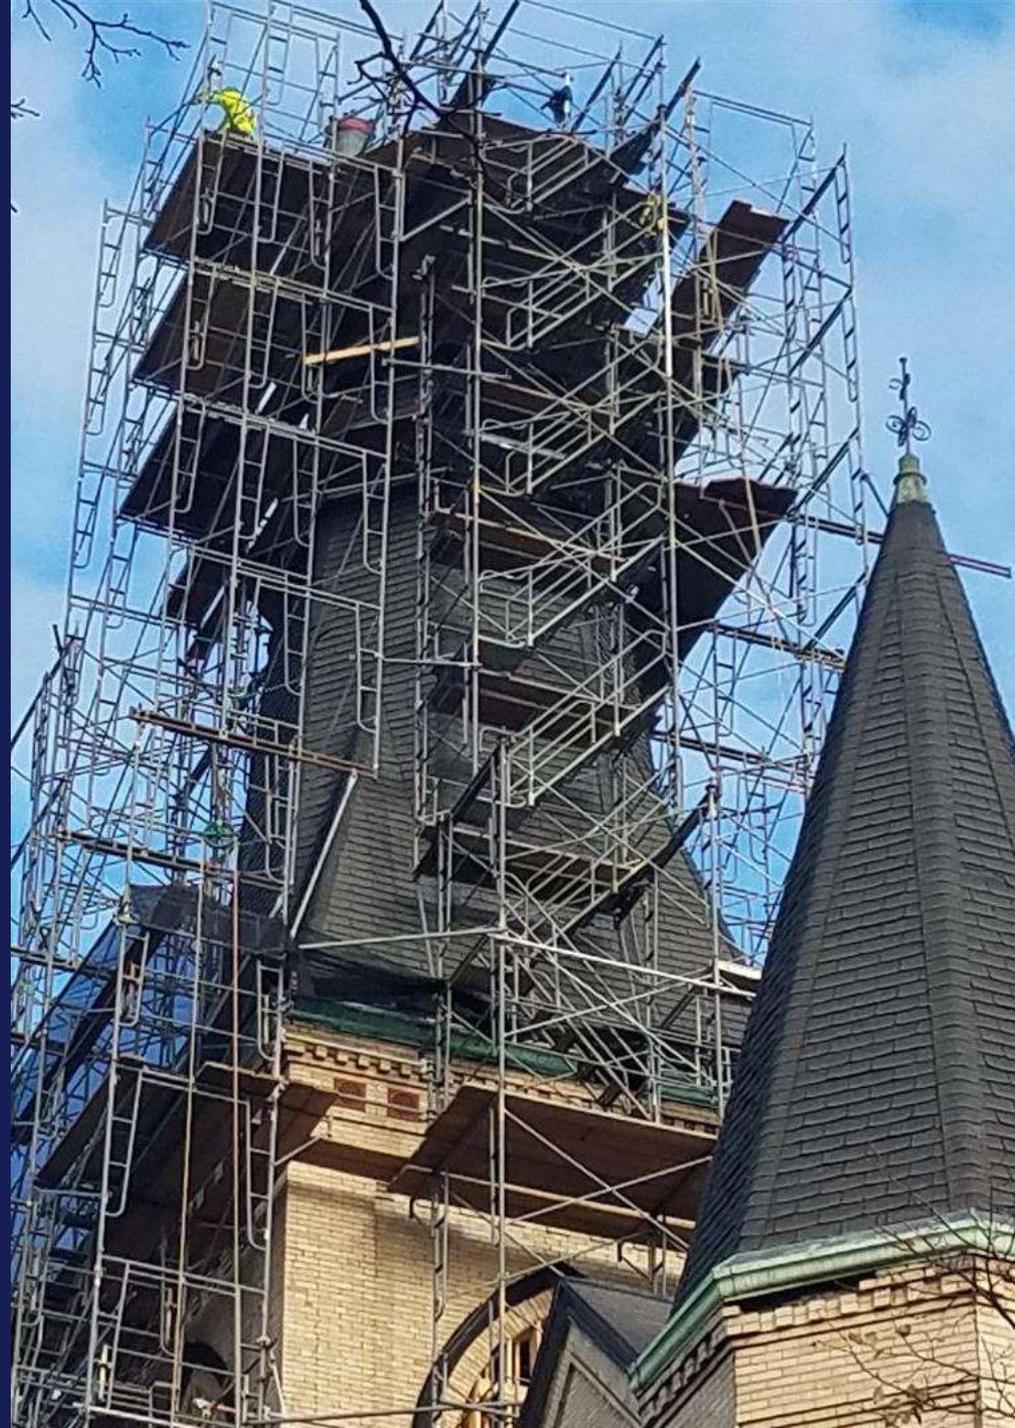
Construction Resumes

- Granite stair foundations replaced
- Tower demolition resumes

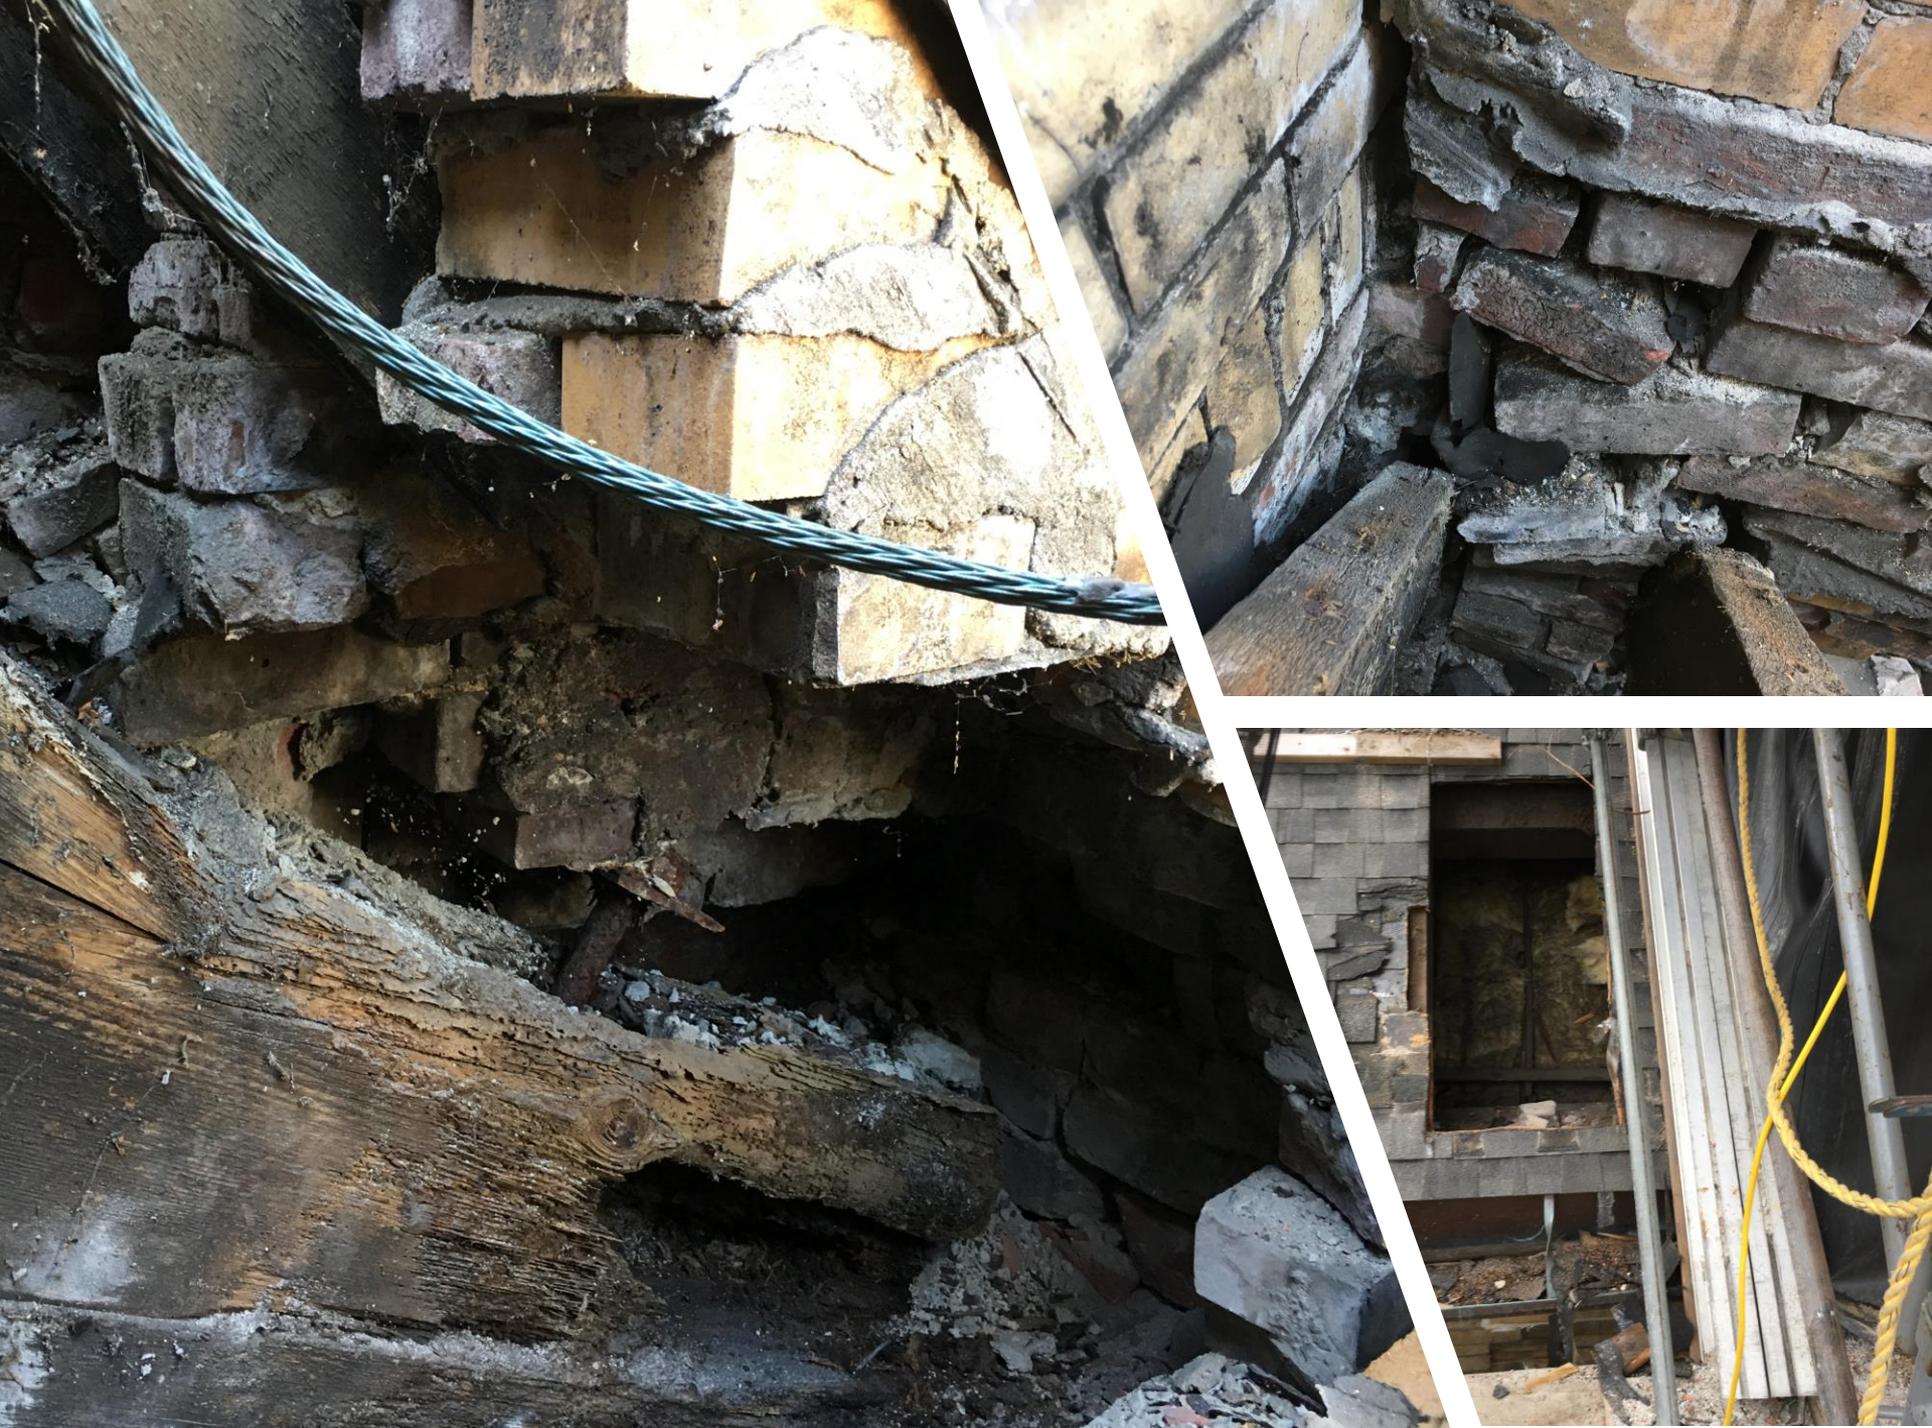
Tower Demolition

- **Poor masonry conditions still exist**
 - Demolition hammers loosen large areas of wall
 - Bricks removed easily by hand
 - Large sections of blonde brick “peeled” away with pry-bar...snapped headers
 - Severely deteriorated joint mortar
- **SGH to provide 2nd opinion on wall integrity and validate Gale’s findings:**
 - SGH agreed with Gale’s assessment that masonry deterioration too extensive to support weight of new belfry and spire

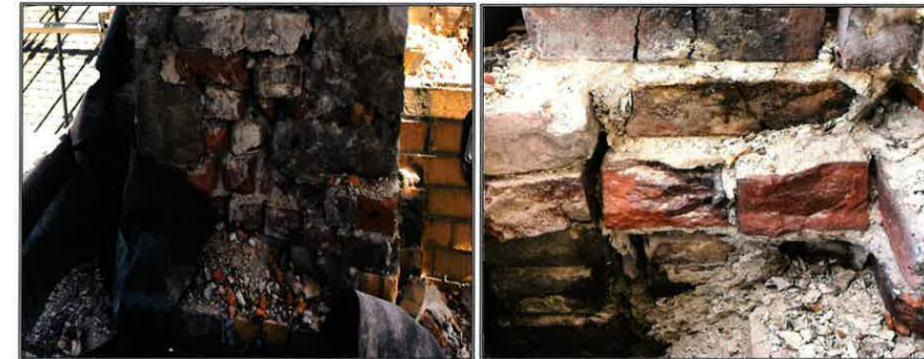
Upon the erection of staging and initiation of construction, Gale visited the site on April 24, 2018 to review the condition of the tower masonry walls as the demolition approached the contract removal limit. Our observations of the mortar at the masonry walls, including the inner red brick wythes, was observed to be in poorer condition than anticipated and subsequently led to overall tower stability concerns on the part of Gale.

Gale recommended that the tower masonry wall demolition operations be ceased until additional evaluation and analysis could be performed. Gale also recommended select interior spaces adjacent to the tower be evacuated, including a portion of the basement/classroom kitchen be closed, along with portions of the first floor and balcony levels. These recommendations were described in Gale's letter dated April 27, 2018 (attached). This letter also included a plan to perform additional masonry test cuts at exterior tower wall locations on Monday and Tuesday of the following week.

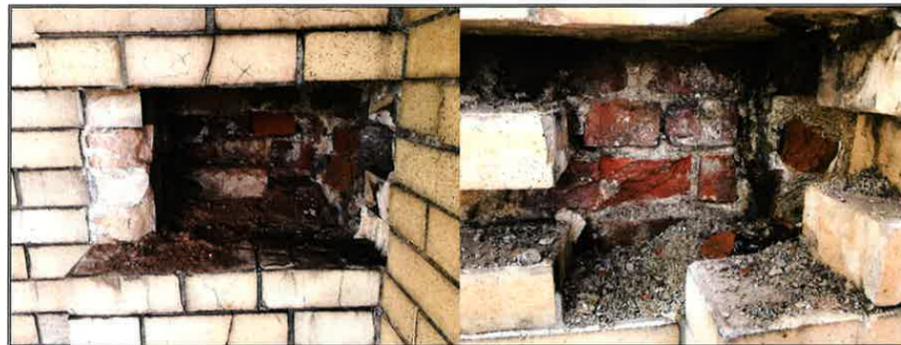
On April 30, 2018 and May 1, 2018, Gale observed ten (10) additional masonry test cuts along the north and west faces of the tower, at various elevations. High variability in the mortar conditions at inner red brick wythes was found to exist throughout and prompted Gale to seek a third-party review from Simpson Gumpertz and Heger (SGH) to confirm Gale's assumptions related to masonry conditions and options for repair.

Based on test cut observations and discussions with SGH, Gale recommended selective tower masonry wall demolition continue, using hand tool techniques only, in an effort to evaluate the undisturbed condition of the inner red brick wythes. We were hoping that the masonry wall would incur reduced damage, which could have been associated with bulk demolition that would have utilized impact hammers. Furthermore, Gale and SGH discussed laboratory testing as a means of acquiring empirical data related to mortar bond strength, but ultimately determined that testing results would be highly subjective based on the inherent challenges of obtaining viable test specimens and the lack of appropriate standardized testing procedures. These findings and recommendations were outlined in a letter dated May 4, 2018 (attached).
