EXISTING NORTHERN AVENUE BRIDGE EVALUATION MEMO

The Northern Avenue Bridge over the Fort Point Channel in Boston MA was originally constructed between 1905 and 1908 and has been repaired / rehabilitated numerous times throughout the years. Due to severe deterioration, the bridge was closed to vehicular traffic in 1997 and closed to pedestrian traffic in 2014. The 2014 closure was prompted by a new revelation that several floor beams supporting the pedestrian walkway had a calculated live load rating capacity of zero tons. This finding was the result of an inspection and rating effort provided by TranSystems. Since then, the bridge has been out of use and left in the swung open positon.

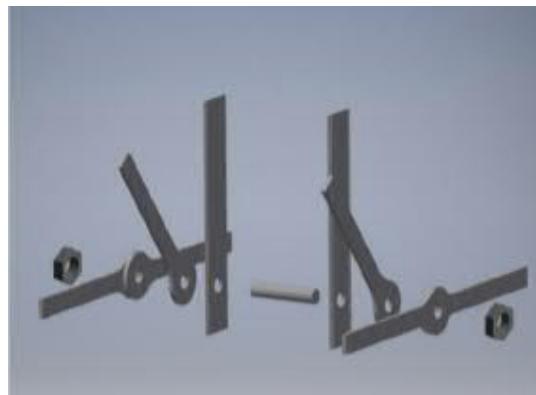
More localized examples include elongation of individual members, which may be a hindrance when reassembling the truss, as they will not line up as intended. This is particularly challenging since all of the 248 pinned connections would need to be disassembled and reassembled. These joints are complex in the sense that there are many connecting elements and plates at the joint, as seen in Images 8 & 9. The

possibility that all of the pieces will not fit back together properly after repairs are made is highly probable. Given the historical cyclic loading of the bridge, it is also possible that the holes in the members that encase the pin have experienced "egging" and are no longer uniform circles, and thus do not provide the same constraints as when they were originally designed. Examples of deformation in the pin and the surrounding members are observed in Images 10 & 11 below. In addition to repairing deterioration in the member cross sections, distortion of the pin holes would also need to be addressed and corrected in order to restore the structural integrity of the pinned connections. Such repairs could potentially be achieved via cover plates, splices, or full member replacements, all of which have the potential to further complicate the joint, particularly in regard to geometric constraints.

Image 9: Model of a Disassembled Pin Connection
